**66AK2E05/02**  
**Multicore DSP+ARM KeyStone II SOC**  
**Silicon Revision 1.0**

# **Silicon Errata**

Literature Number: SPRZ417B  
May 2014–Revised August 2015

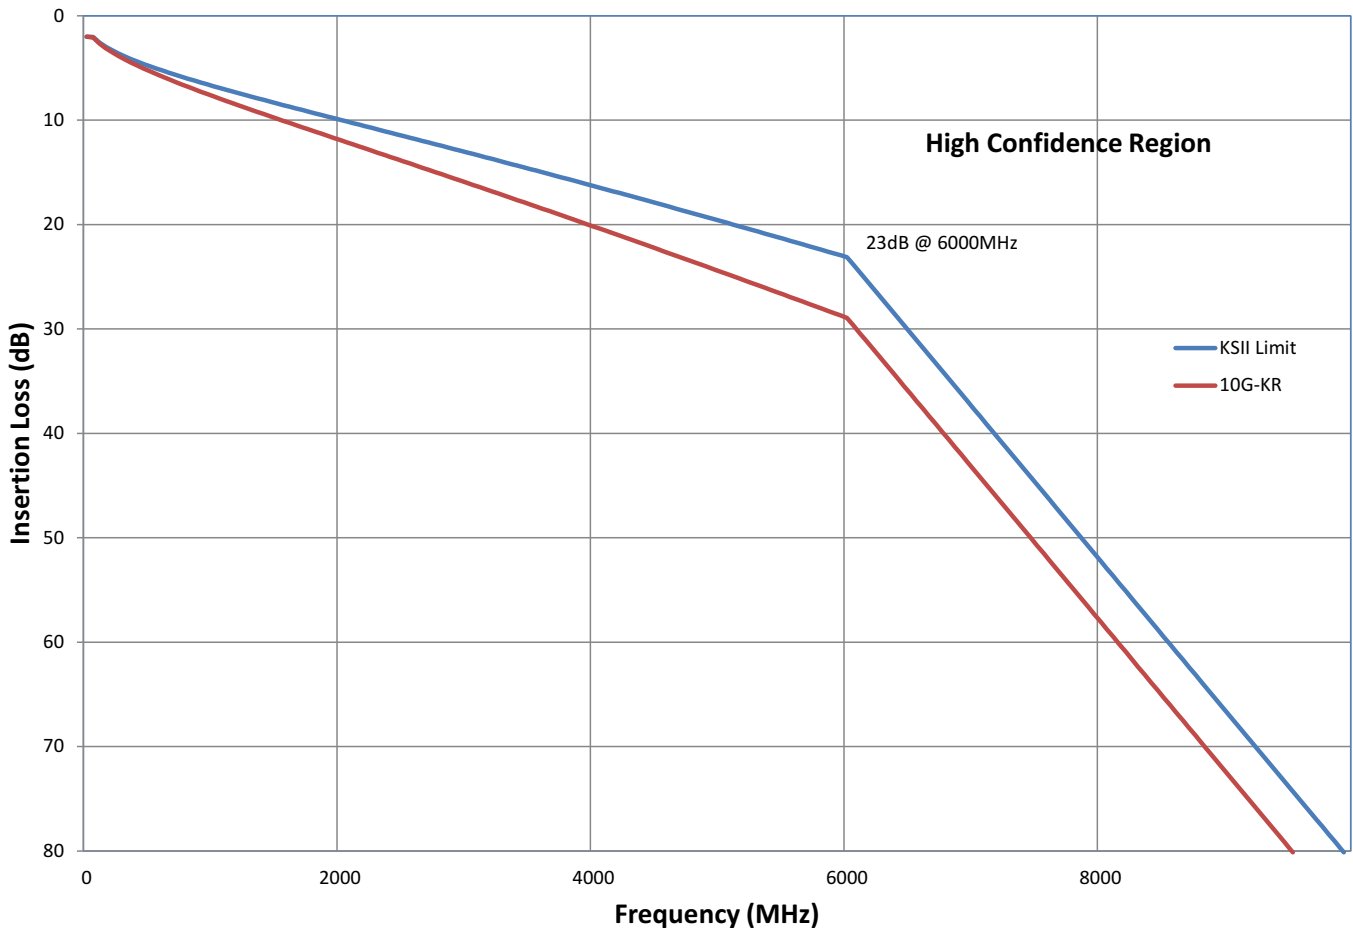
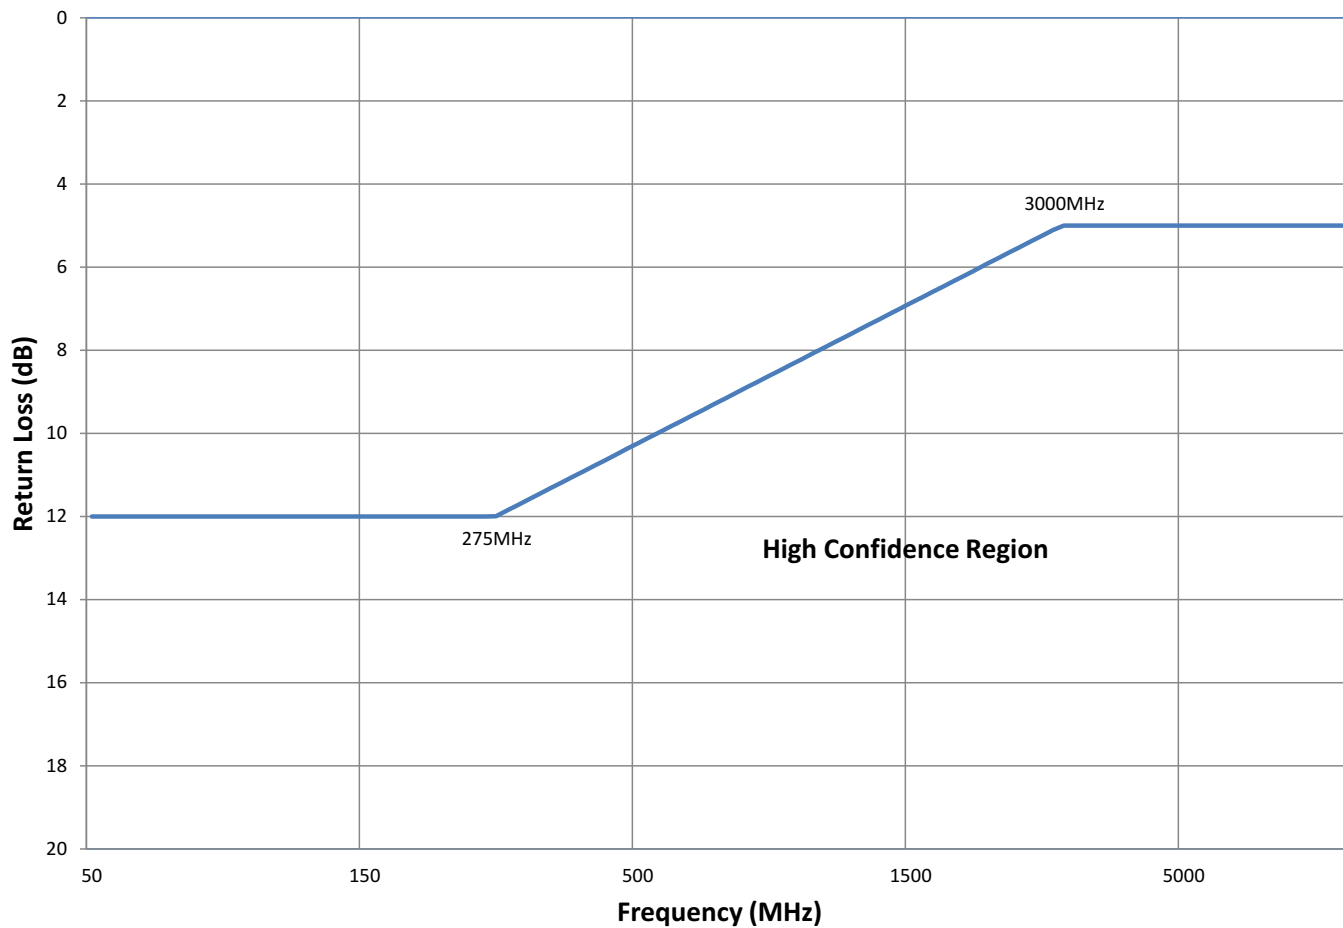
Device characterization has shown that bit error rate performance consistent with the 10GbE-KR standard as published in IEEE 802.3-2008 Annex 69B cannot be met across all device operating extremes. Production devices do operate at the required error rate across all rated operating conditions of voltage and temperature when the channel insertion loss is limited to 20dB at the Nyquist rate of 5.15625GHz. The figure below shows the Insertion Loss template from IEEE 802.3-2008 Annex 69B as well as the reduced Insertion Loss template.

Characterization has shown that channels must also be compliant with the Return Loss template contained in the IEEE 802.3-2008 Annex 69B specification without modification. This is shown below for convenience.

None.

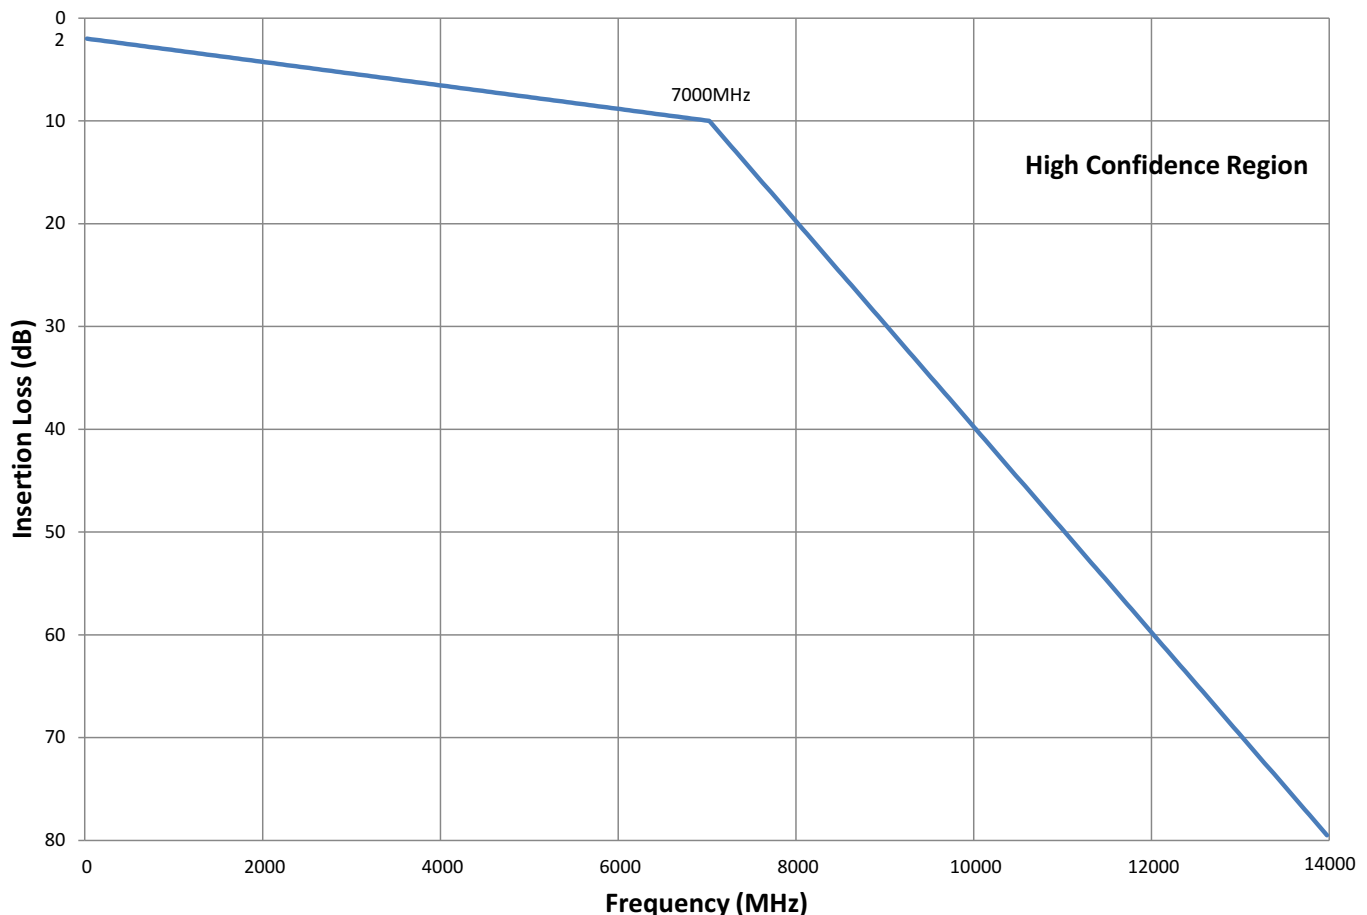
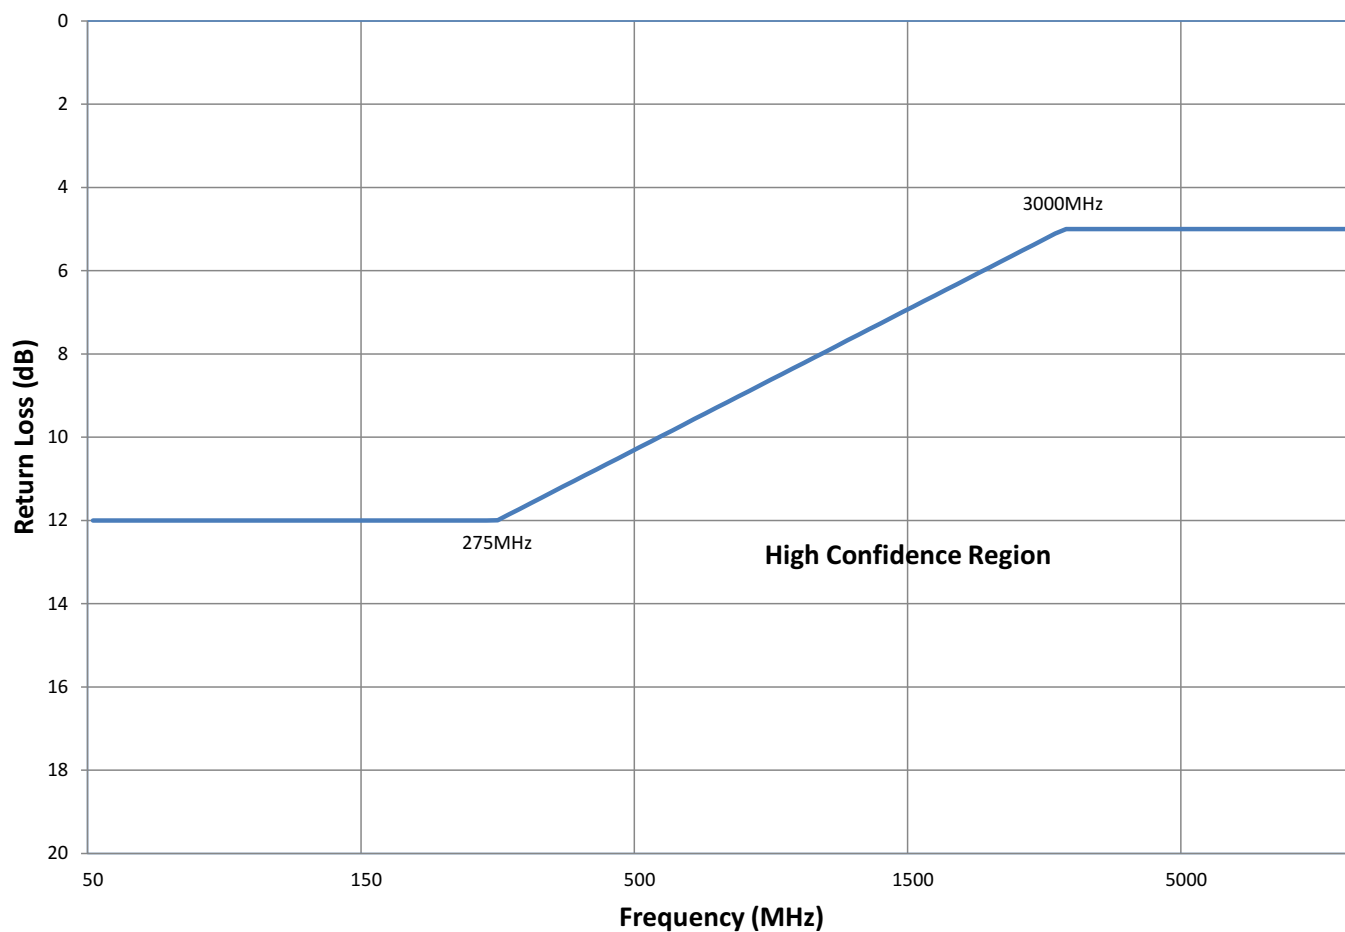
Device characterization has shown that expected bit error rate performance can only be met on layouts that meet constrained channel loss metrics. These can be examined by generating Insertion Loss and Return Loss graphs where loss is plotted versus frequency. Insertion Loss and Return Loss can be estimated during PCB layout using a 3D simulation tool. Insertion Loss and Return Loss should also be measured on early prototypes using a Vector Network Analyzer (VNA). Multiple PCB construction and layout enhancement techniques must be combined to achieve these channel performance requirements as stated in the KeyStone II SERDES User Guide.

An Insertion Loss measurement provides a composite view of the channel's loss versus frequency. Since HyperLink is a short-reach interface, channel loss is limited. Also, due to the high data rate, the Insertion Loss must be monotonic and without discontinuities that would degrade receiver operation. The template shown below provides Insertion Loss limits that will result in a robust channel. This template must be met for the entire channel from transmitter to receiver including the series capacitors.

Device characterization has also shown that channels should be compliant with the Return Loss template shown below. The Return Loss measurement indicates the amount of energy reflected back to the source which is not available to the receiver. Impedance variation in the channel will cause reflected energy that can cause this template to be violated. Careful attention to PCB construction and layout must be followed to meet this requirement. This template must be met for the entire channel from transmitter to receiver including the series capacitors. Note that this is the same template

None.

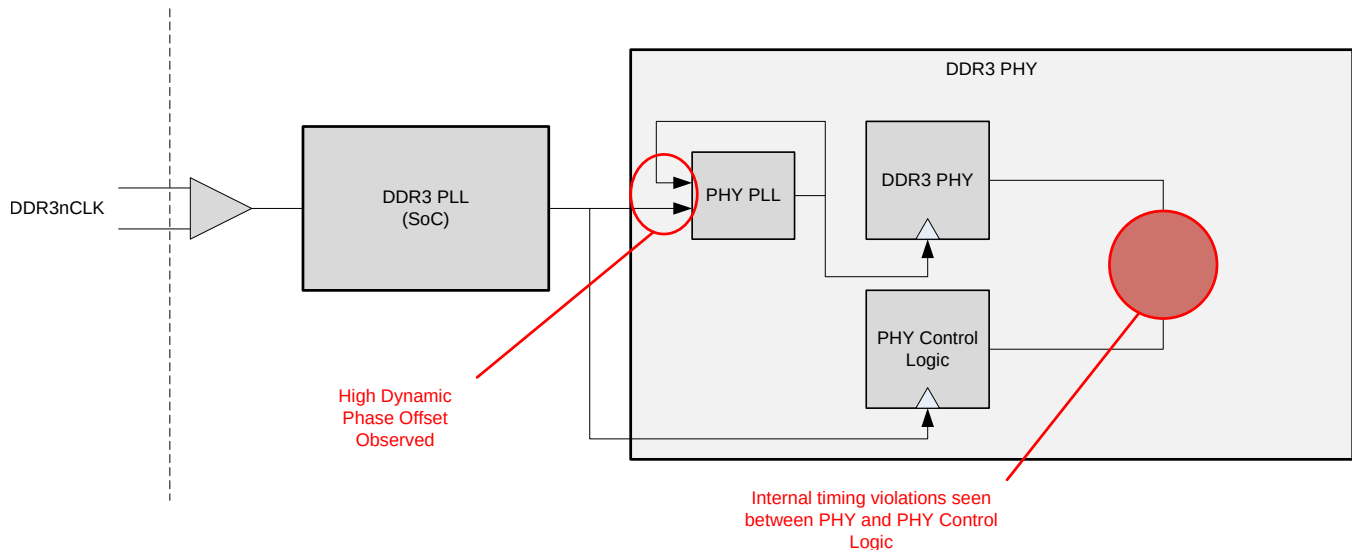
**Figure 2. DDR3 PHY**

DDR3 read operations may show errors due to increased levels of Dynamic Phase Offset (DPO) inside the DDR3 PHY. These errors are characterized by byte lane data corruption or intermittent bit errors. The byte lane data corruption can only be recovered using a device reset.

The DDR3 clocking architecture is illustrated in the figure below. The DDR3 reference clock input (DDR3nCLK) feeds the DDR3 SoC PLL, which outputs a clock to be used by the PHY Control Logic and provide an input to the PHY PLL.

The Dynamic Phase Offset (DPO) is a measure of the DDR3 PHY PLL's ability to track rapid phase changes in the output of the DDR3 SoC PLL. High DPO can create internal timing violations between the DDR3 PHY and DDR3 PHY Control Logic and result in data errors during reads. As indicated by the shaded red circle in the figure above, the timing violations occur in the data transfer between the PHY and PHY control logic. It was determined that the root cause of the elevated DPO were SoC PLL and PHY PLL configurations that were non-optimized for the timing requirements of the system.

The workaround for this behavior is a change in the PLL configurations used for the DDR3 SoC PLL and the DDR3 PHY PLL. New configurations have been generated for DDR3-1600, DDR3-1333, DDR3-1066, and DDR3-800 operation and are presented in the tables below. Per field alert, "DDR3 Limited to Highest Data Rates Due to Possibility of PLL Instability During Temperature Changes after Startup", operation of DDR3-1066 and/or DDR3-800 is not recommended for affected Keystone2 devices in production systems

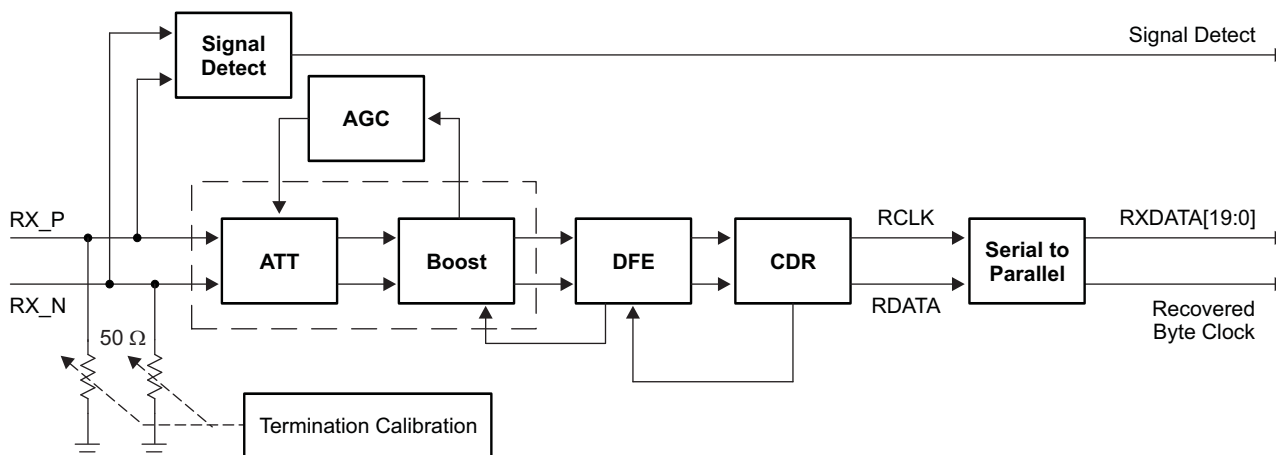
**Figure 3. RX Path Block Diagram**

**Problem Summary:** The SerDes on some peripherals will not automatically adapt its RX equalization when provided with certain data encodings common to that peripheral's electrical standard.

**Details** The TI SerDes contains an adaptation algorithm that allows the RX equalization blocks to adapt their parameters to the SerDes data channel. The adaptation algorithm sets the optimal values for the ATT, BOOST, and DFE blocks in order to equalize the signal, maximize margin, and minimize channel distortion. For higher data rates (i.e. 5Gbps and greater), the high frequency gain provided by the BOOST block is generally considered necessary to compensate for the low-pass characteristics of data channels and widen the data eye.

The SerDes BOOST block was designed to require a specific set of patterns in order to best adapt its parameters to the channel. If these patterns are not found, the BOOST adaptation algorithm will not update the internal block settings and/or may incorrectly update these settings. The required data pattern is a series of six 0's followed by a 101 pattern. This pattern must occur numerous times on both odd and even bit alignments. This data pattern is not present in the 8b/10b coded symbols that are sent over many of the high speed peripheral links.

The recommended workaround is to not use the RX equalization auto-adaptation mechanism with the impacted interfaces at higher data rates. As an alternative, a user can hardcode the optimal ATT and BOOST values for their channel.

The optimal ATT and BOOST values found by one of the two above methods can be hardcoded into the SerDes upon initialization.
