# **AM335x Sitara™ Processors**

## **Silicon Revisions 2.1, 2.0, 1.0**

# **Silicon Errata**

Literature Number: SPRZ360I  
October 2011 – Revised January 2017

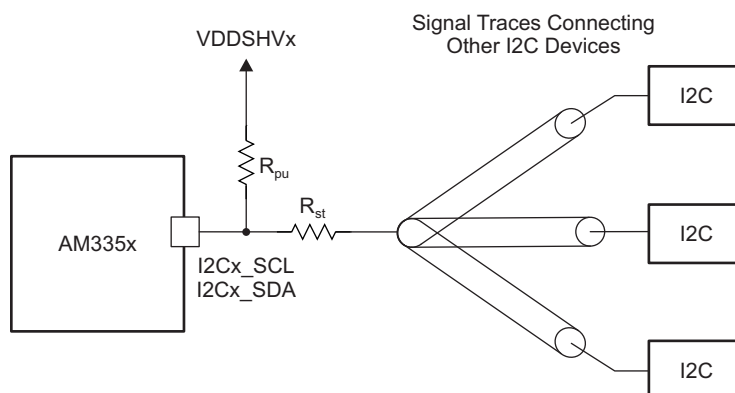
**Figure 4. Placement of Series Termination Resistor and Pullup Resistor**

The I2Cx\_SDA and I2Cx\_SCL outputs are implemented with push-pull 3-state output buffers rather than open-drain output buffers as required by I2C. While it is possible for the push-pull 3-state output buffers to behave as open-drain outputs, an internal timing skew issue causes the outputs to drive a logic-high for a duration of (0–5 ns) before the outputs are disabled. The unexpected high-level pulse will only occur when the SCL or SDA outputs transition from a driven low state to a high-impedance state and there is sufficient internal timing skew on the respective I2C output.

This short high-level pulse injects energy in the I2C signals traces, which causes the I2C signals to sustain a period of ringing as a result of multiple transmission line reflections. This ringing should not cause an issue on the SDA signal because it only occurs at times when SDA is expected to be changing logic levels and the ringing will have time to damp before data is latched by the receiving device. The ringing may have enough amplitude to cross the SCL input buffer switching threshold several times during the first few nanoseconds of this ringing period, which may cause clock glitches. This ringing should not cause a problem if the amplitude is damped within the first 50 ns because I2C devices are required to filter their SCL inputs to remove clock glitches. Therefore, it is important to design the PCB signal traces to limit the duration of the ringing to less than 50 ns. One possible solution is to insert series termination resistors near the AM335x SCL and SDA terminals to attenuate transmission line reflections.

This issue may also cause the SDA output to be in contention with the slave SDA output for the duration of the unexpected high-level pulse when the slave begins its ACK cycle. This occurs because the slave may already be driving SDA low before the unexpected high-level pulse occurs. The glitch that occurs on SDA as a result of this short period of contention does not cause any I2C protocol issue but the peak current applies unwanted stress to both I2C devices and potentially increases power supply noise. Therefore, a series termination resistor located near the respective AM335x SDA terminal is required to limit the current during the short period of contention.

A similar contention problem can occur on SCL when connected to I2C slave devices that support clock stretching. This occurs because the slave is driving SCL low before the unexpected high-level pulse occurs. The glitch that occurs on SCL as a result of this short period of contention does not cause any I2C protocol issue because I2C devices are required to apply a glitch filter to their SCL inputs. However, the peak current applies unwanted stress to both I2C devices and potentially increases power supply noise. Therefore, a series termination resistor located near the respective AM335x SCL terminal is required to limit the current during the short period of contention.

Insert series termination resistors on the SCL and SDA signals and locate them near the AM335x SCL and SDA terminals. The SCL and SDA pullup resistors should also be located near the AM335x SCL and SDA terminals. The placement of the series termination resistor and pullup resistor should be connected as shown in [Figure 4](#).

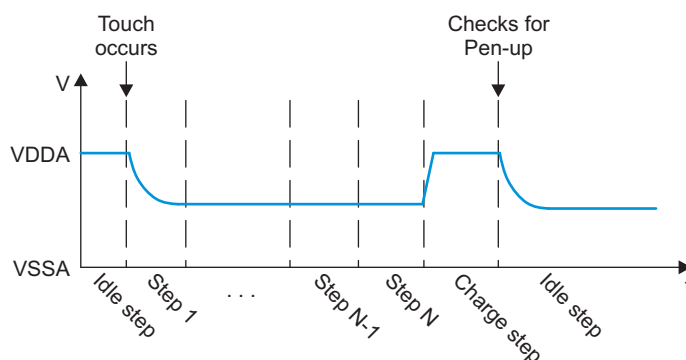
**Figure 5. TSC Generates False Pen-up Interrupt**

The touchscreen controller (TSC) determines the pen state (up or down) by checking the respective analog input (AIN0 for 4-wire or AIN4 for 5-wire) voltage level immediately after the Charge step. This does not provide enough time for the analog input voltage to return to the normal Pen-down voltage before testing the pen state. This will cause the TSC to generate a false Pen-up interrupt if the Charge step is enabled with the strong pull-up turned on when using hardware synchronized steps. [Figure 5](#) illustrates the effect on the analog voltage when constant pen pressure is applied to the touchscreen and held through the Charge step.
