## ***AM572x Sitara™ Processors***

### ***Silicon Revision 2.0, 1.1***

## 1 Introduction

This document describes the known exceptions to the functional specifications for the device.

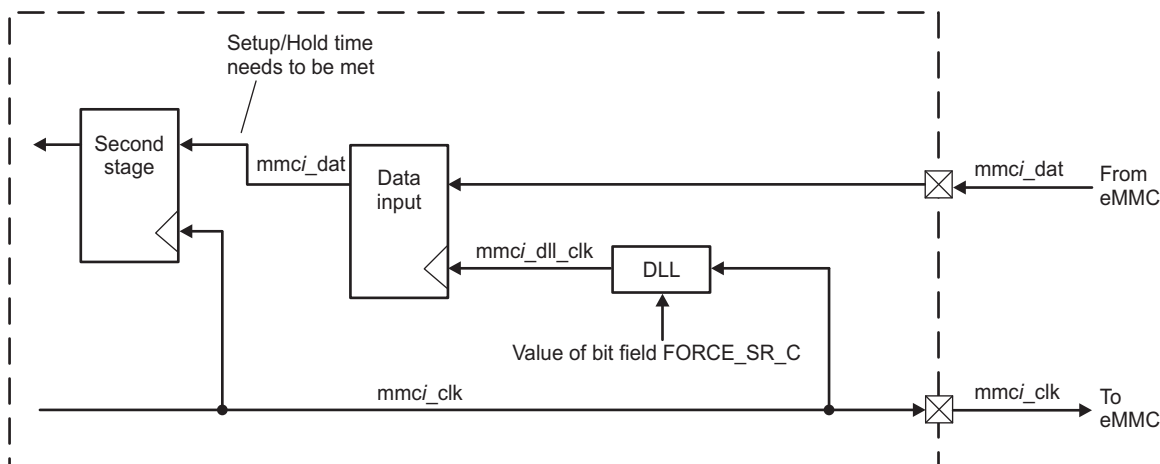
### Figure 2. Simplified SoC 192-MHz Mode DLL Block Diagram

Internal to the MMC module, a second stage latch is used to recapture data captured by DLL delayed CLK, MMC\_DLL\_CLK. The second stage latch captures with the original transmitting clock, MMC\_CLK.

MMC\_DLL\_CLK and MMC\_CLK both run at the same clock frequency. This results in a narrow range of tuning ratio elements, where the delayed MMC\_DLL\_CLK comes in phase with MMC\_CLK. If the clocks are in phase, the data captured by the first clock violates the setup and hold time requirements needed for the second stage latch, resulting in incorrectly read data. This is known as tuning re-timing errors.

A DLL tuning algorithm has been implemented that can avoid the tuning re-timing errors. More details on this can be found in App Note [SPRACA9](#). The following notes summarize the updated algorithm:

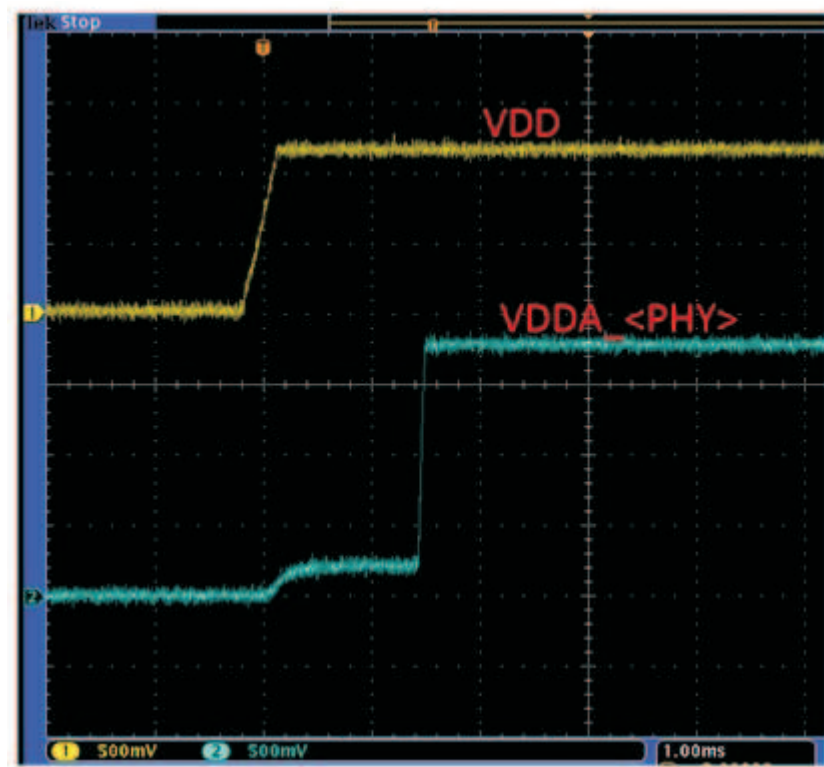
**Figure 4. Leakage Voltage**

The device-specific Data Manual requires Core AVS rail (VDD) to power up before the 1.8 V high speed analog PHY domain(s). When this sequence is followed, the high speed analog PHY domain will have a small step-up to a voltage plateau (< 0.5 V) that aligns to the beginning of the VDD ramp-up, and is maintained until the ramp-up of high speed analog PHY rail, as shown in [Figure 4](#). Note the leakage value will differ from system to system, but will be less than 500 mV. The leakage voltage in the provided capture is approximately 250 mV.

A similar condition exists during supply power down sequence. The high speed analog PHY domain(s) are required to be powered down prior to Core AVS rail (VDD), and may cause a small plateau to exist until Core AVS rail (VDD) is ramped down.

The root cause of the voltage plateau during power-up/down sequencing is related to the parasitic diodes in logic blocks which have multiple power sources. This leakage path is not a reliability concern for this device.
