## AT21CS01 Silicon Errata

The AT21CS01 devices that you have received conform functionally to the current Device Data Sheet (DS20005857B), except for the anomalies described in this document.

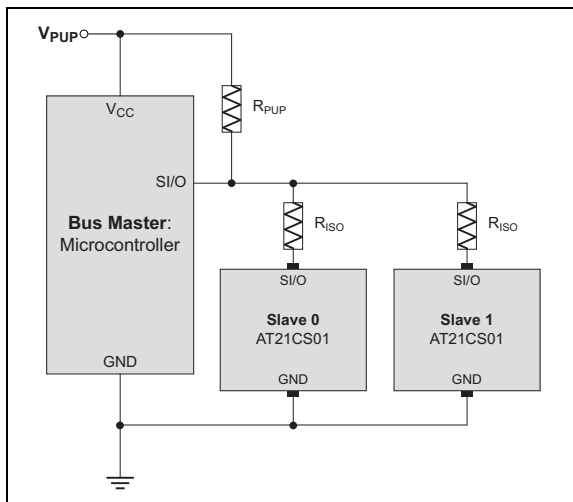
**FIGURE 1: EXAMPLE SCHEMATIC**

When multiple AT21CS01 devices are present on the single-wire bus, one or more devices may not reset properly after a device Reset or power-up event.

The device(s) that are not reset properly may remain active (driving SI/O low) following the device Reset or power-up event, resulting in corrupted communication.

Modify the firmware to force SI/O high during the entire  $t_{DACK}$  period following a device Reset or power-up event. Series resistors must be added to isolate the slave devices and reduce the output current. In addition, narrowing the Pull-Up Voltage  $V_{PUP}$  range may be necessary to meet timing and I/O level requirements during communication. [Figure 1](#) is an example Schematic with the isolation resistors  $R_{ISO}$ .
