**AT89C51CC03**

**AT89C51CC03C**

**AT89C51CC03U**

## Errata Sheet

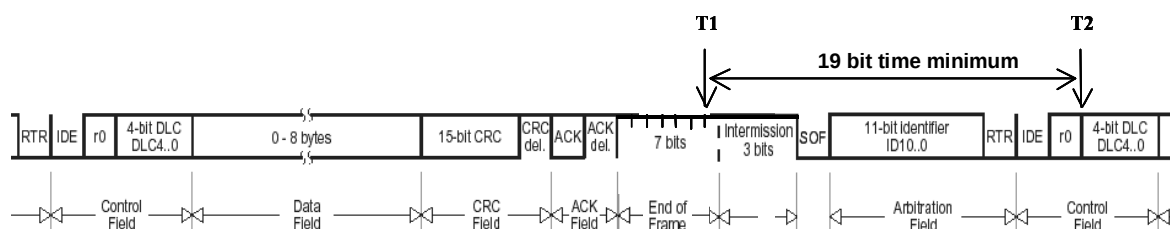
### CAN2.0A

If the transmitter lost arbitration against another node, two conditions can occur :

1. At least one Receive MOB of the chip are programmed to accept the incoming message. In this case, the transmitter will wait for the next 3-bit Intermission to retry its transmission.
2. No Receive MOB of the chip are programmed to accept the incoming message. In this case the transmitter will wait for a 4-bit Intermission to retry its transmission. In this case, any other CAN nodes ready to transmit after a 3-bit Intermission will start transmit before the chip transmitter, even if their messages have lower priority IDs.

Always have a Receive MOB enabled ready to accept any incoming messages. Thanks to the implementation of the CAN interface, a Receive MOB must be enable at latest, before the 1<sup>st</sup> bit of the DLC field. The Receive MOB status register is written (RXOK if message OK) immediately after the 6th bit of the End of Frame field. This will leave in CAN2.0A mode a minimum 19-bit time delay to respond to the end of message interrupt (RXOK) and re-enable the Receive MOB before the start of the DLC field of the next incoming message. This minimum delay will be 39-bit time in CAN2.0B. See CAN2.0A CAN2.0B frame timings below.
