## **CC1101 Silicon Errata**

**Table 1. Advisory List**

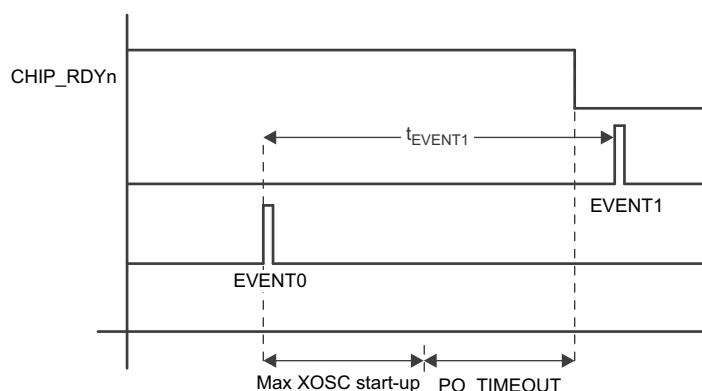
**Details** If EVENT1 occurs after the XOSC has stabilized but before CHIP\_RDYn goes low (during the PO\_TIMEOUT period), there is a small probability that the radio enters an illegal state, causing the radio to miss EVENT1. If this happens, the internal SRX strobe never takes place and the chip does not enter RX mode. On the next EVENT1, the crystal is running and CHIP\_RDYn is already asserted, so the radio will enter RX as it should, and then go back to SLEEP (if no packets are received).

**Workaround(s)** To avoid this happening,  $t_{\text{Event1}}$  must be programmed to be larger than the maximum startup time of the crystal + PO\_TIMEOUT.

$$t_{\text{Event1}} > \text{Max XOSC Startup} + \text{PO\_TIMEOUT}$$
