# USBXpress™ Family

## CP2102N Errata

Errata effective date: March, 2019.

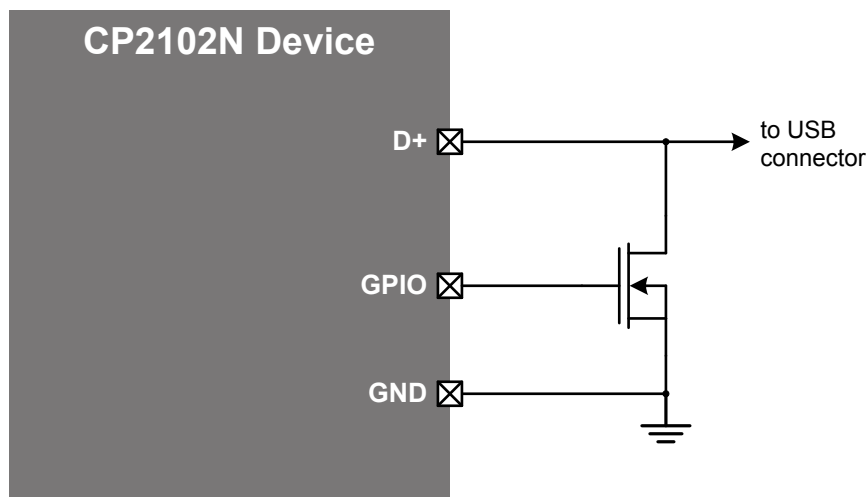
### 2.1 CP2102N\_E110 – USB D+/D- Power-On Reset

| Description of Errata |
|---|
| During and immediately following power-on reset, the USB D+ and D- pins are undefined. These pins can be logic high, logic low, or mid-supply. This behavior typically lasts for ~15 ms, at which point the D+ and D- pins operate normally. The USB specification provides a 100 ms settling/debounce period after power-on. |
| Some USB host devices may require the USB D+ and D- pins be in a known state during or immediately following power-on reset to start properly. |

| Description of Errata |
|---|
| <p>Adding an external circuit to the USB D+ and D- pins can force the desired state on these pins during and immediately following power-on reset. The rising edge of RSTb signals the end of power-on reset.</p> <p>An example circuit is shown below:</p> <p>This circuit uses an NMOS transistor and a GPIO pin to short D+ to ground during power-on. The GPIO pin will be open drain and pulled high through a weak pull-up during reset. The GPIO should be configured so that the <b>[Reset Latch]</b> value is <b>[Low]</b>, which turns off the transistor after reset and enables the device to enumerate normally. GPIO can be configured using Xpress Configurator in Simplicity Studio v4 (<a href="http://www.silabs.com/simplicity">www.silabs.com/simplicity</a>).</p> |
