**ENC424J600/624J600 Silicon Errata  
and Data Sheet Clarification**

The ENC424J600/624J600 devices that you have received conform functionally to the current Device Data Sheet (DS39935B), except for the anomalies described in this document.

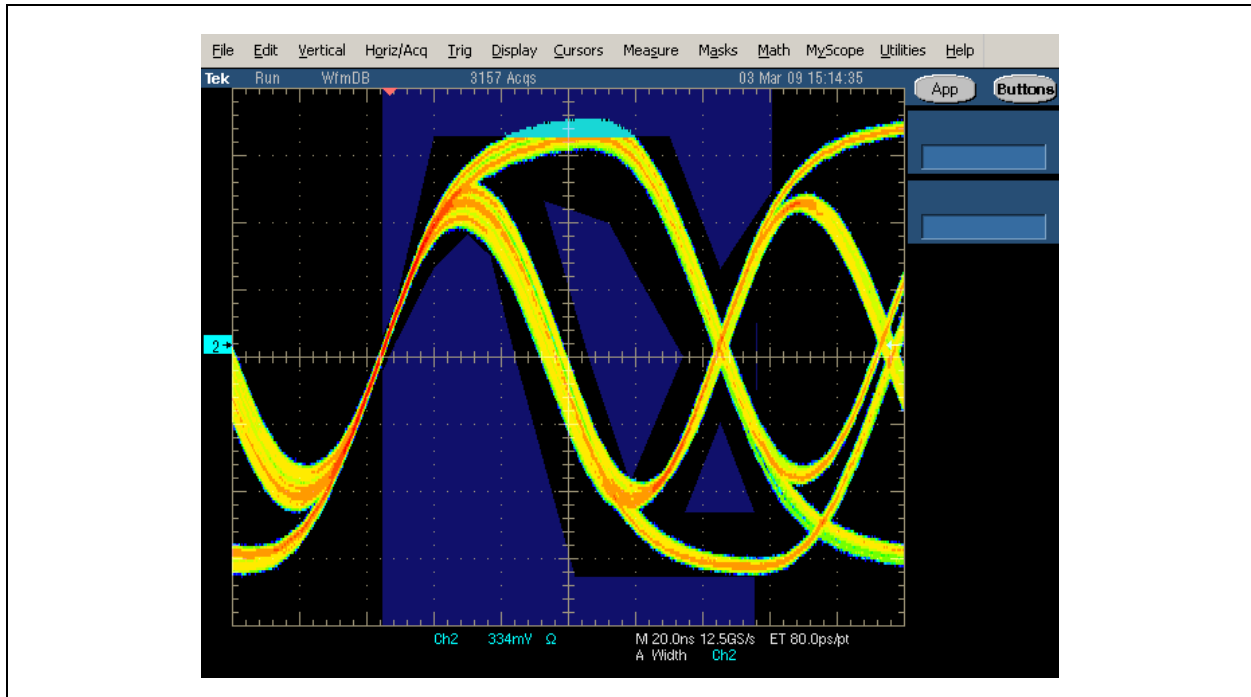
FIGURE 1: 10Base-T MAU EYE DIAGRAM

When transmitting random data in 10Base-T mode, the PHY transmit waveform slightly violates the MAU eye diagram keep-out zones specified in the IEEE 802.3™ Std. 2005, Section 14.3.1.2.1. Specifically, the waveform amplitude is slightly too high for '0' to '1' and '1' to '0' bit transitions when tested against the twisted-pair model, as shown in Figure 1.

This issue applies only to 10 Mbps speed and is unlikely to cause compatibility problems in real networks. When terminated with a 100Ω resistor without the twisted-pair model, the transmit waveform stays within the amplitude limits of +2.2V to +2.8V and -2.2V to -2.8V required by the standard.

None.
