## ***F28M36x Concerto™ MCUs Silicon Errata Silicon Revisions F, E, B, A, 0***

This document describes the silicon updates to the functional specifications for the F28M36x microcontrollers (MCUs).

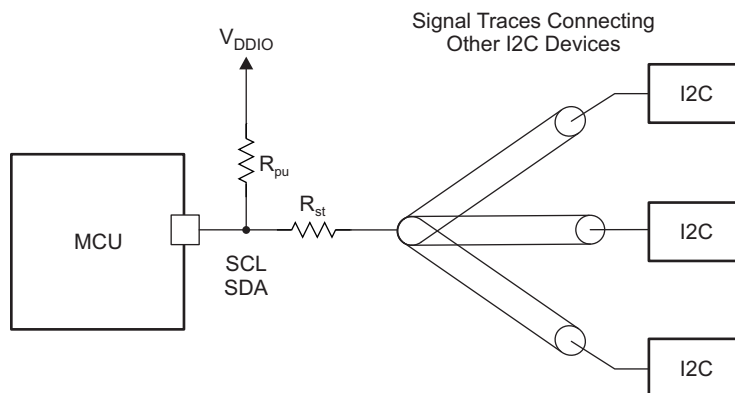
**Figure 8. Placement of Series Termination Resistor and Pullup Resistor**

The SDA and SCL outputs are implemented with push-pull 3-state output buffers rather than open-drain output buffers as required by I2C. While it is possible for the push-pull 3-state output buffers to behave as open-drain outputs, an internal timing skew issue causes the outputs to drive a logic-high for a duration of 0–5 ns before the outputs are disabled. The unexpected high-level pulse will only occur when the SCL or SDA outputs transition from a driven low state to a high-impedance state and there is sufficient internal timing skew on the respective I2C output.

This short high-level pulse injects energy in the I2C signals traces, which causes the I2C signals to sustain a period of ringing as a result of multiple transmission line reflections. This ringing should not cause an issue on the SDA signal because it only occurs at times when SDA is expected to be changing logic levels and the ringing will have time to damp before data is latched by the receiving device. The ringing may have enough amplitude to cross the SCL input buffer switching threshold several times during the first few nanoseconds of this ringing period, which may cause clock glitches. This ringing should not cause a problem if the amplitude is damped within the first 50 ns because I2C devices are required to filter their SCL inputs to remove clock glitches. Therefore, it is important to design the PCB signal traces to limit the duration of the ringing to less than 50 ns. One possible solution is to insert series termination resistors near the SCL and SDA terminals to attenuate transmission line reflections.

This issue may also cause the SDA output to be in contention with the slave SDA output for the duration of the unexpected high-level pulse when the slave begins its ACK cycle. This occurs because the slave may already be driving SDA low before the unexpected high-level pulse occurs. The glitch that occurs on SDA as a result of this short period of contention does not cause any I2C protocol issue but the peak current applies unwanted stress to both I2C devices and potentially increases power supply noise. Therefore, a series termination resistor located near the respective SDA terminal is required to limit the current during the short period of contention.

A similar contention problem can occur on SCL when connected to I2C slave devices that support clock stretching. This occurs because the slave is driving SCL low before the unexpected high-level pulse occurs. The glitch that occurs on SCL as a result of this short period of contention does not cause any I2C protocol issue because I2C devices are required to apply a glitch filter to their SCL inputs. However, the peak current applies unwanted stress to both I2C devices and potentially increases power supply noise. Therefore, a series termination resistor located near the respective SCL terminal is required to limit the current during the short period of contention.

Insert series termination resistors on the SCL and SDA signals and locate them near the SCL and SDA terminals. The SCL and SDA pullup resistors should also be located near the SCL and SDA terminals. The placement of the series termination resistor and pullup resistor should be connected as shown in [Figure 8](#).

Table 6 provides series termination and pullup resistor value recommendations. The I2C signal level and respective  $V_{DDIO}$  power supply voltage is shown in the first column. Two resistor value combination options are provided for each voltage. One option supports a maximum high-level input current of 200  $\mu A$  to all attached I2C devices, while the other option supports a maximum high-level input current of 100  $\mu A$  to all attached I2C devices.
