## KSZ8041 Silicon Errata and Data Sheet Clarification

This document describes known silicon errata for the KSZ8041 family of devices, which includes the following:

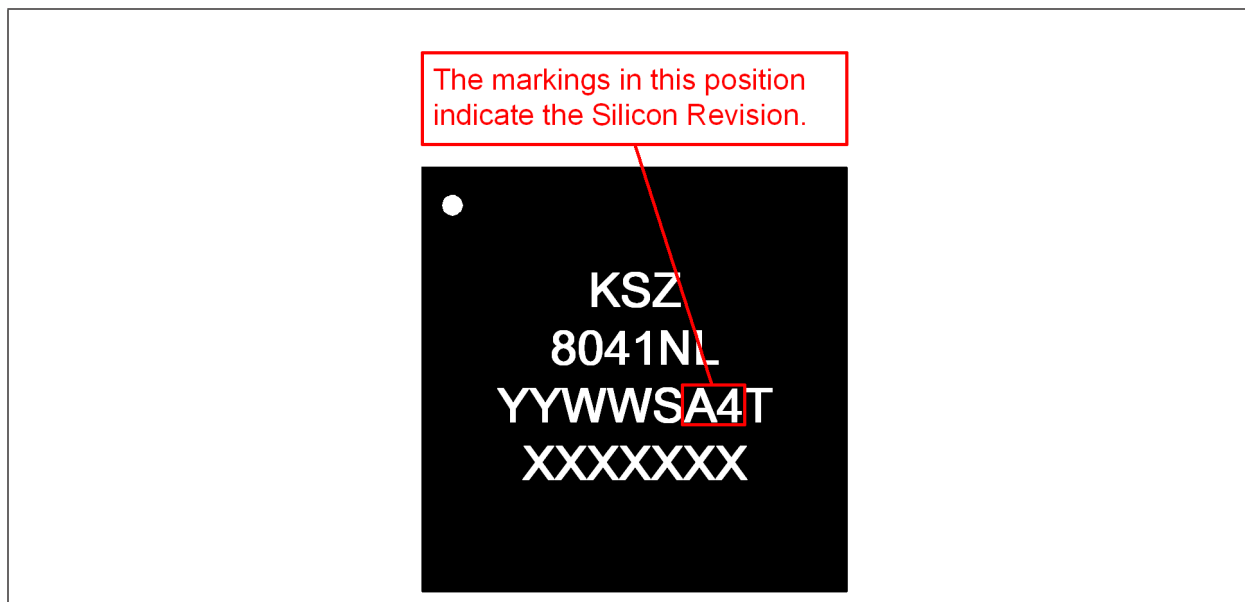
**FIGURE 1: TOP MARKING SILICON REVISION INDICATION**

The silicon errata discussed in this document are for silicon with silicon revisions as listed in [Table 1](#). The silicon revision can be determined by the device's top marking as indicated in [Figure 1](#). A summary of KSZ8041 silicon errata is provided in [Table 2](#).

**Note:** The purpose of [Figure 1](#) is to detail the top markings of an example part and highlight the location of the silicon revision. Other top marking values may differ (lot codes, location of manufacture, etc.).

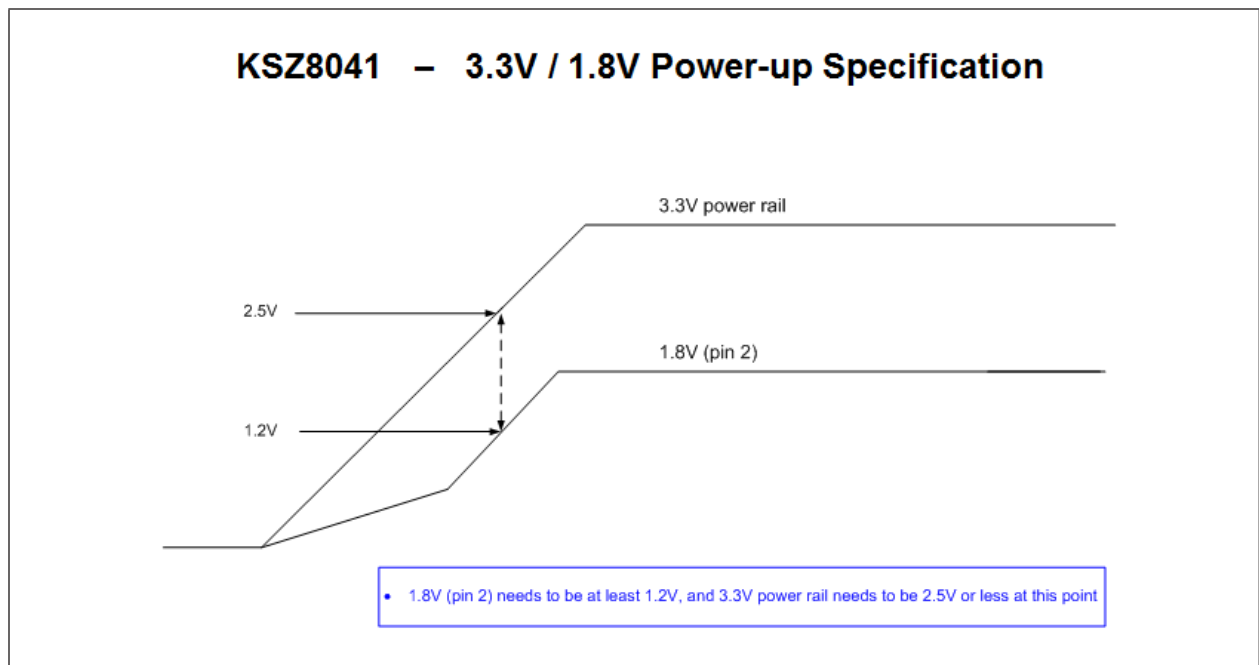
A small percentage (<1%) of devices can potentially encounter pin strapping failures with fast 3.3V supply rise times (<150us) or slow core rail rise times, due to a large bulk storage capacitor value (10uF or greater) for the 1.8V core.

When this errata occurs, pin strap values may not be correctly latched.

Reduce the 1.8V core bulk storage capacitor from 10uF to 1.0uF and ensure the 3.3V supply rise time is 250us or greater.
