## KSZ9031MNX Silicon Errata & Data Sheet Clarification

This document describes known silicon errata for the Microchip KSZ9031MNX device, which include the following variants:

- KSZ9031MNXCA
- KSZ9031MNXCC
- KSZ9031MNXIA
- KSZ9031MNXIC

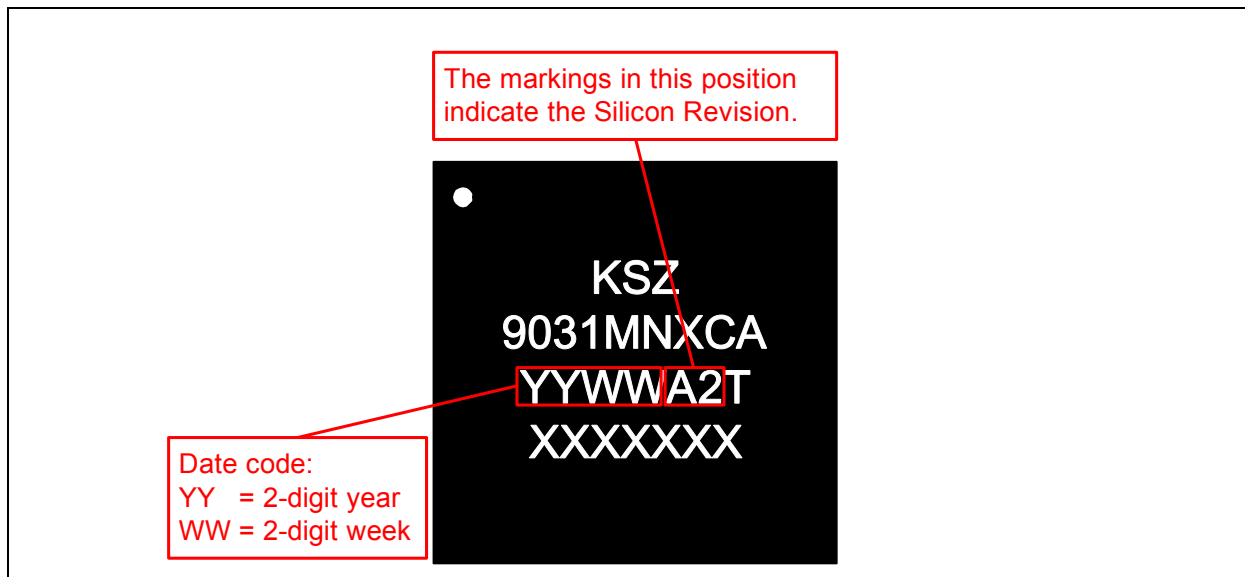
**FIGURE 1: TOP MARKING DATE CODE INDICATION**

The silicon errata discussed in this document are for silicon revisions as listed in [Table 1](#). The silicon revision can be determined by the device's top marking as indicated in [Figure 1](#). A summary of KSZ9031MNX silicon errata is provided in [Table 2](#).

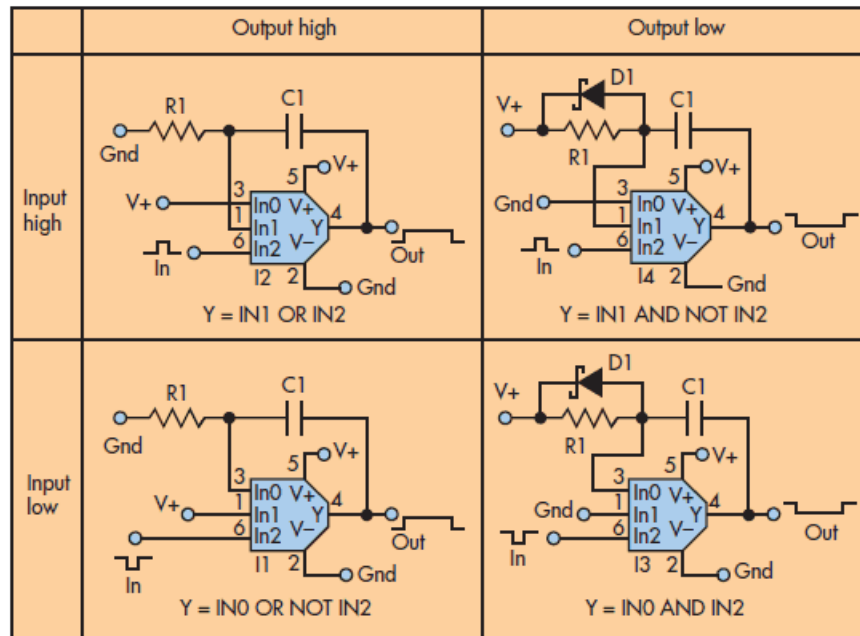
**FIGURE 2: LED CONFIGURATION**

In Tri-color Dual-LED mode, the LED[2:1] pin outputs toggle high pulses for transmit/receive activity indication. The high pulse width incorrectly tracks the activity data rate. At low data rate (e.g., one frame per second), the LED pin drives high (OFF) with a narrow high pulse width of about 640ns.

Typically, the LED toggle rate should be <10Hz (100ms clock period or 50ms high pulse width) to be visible to the human eye. A 640ns pulse is not visible.

If Tri-color Dual-LED mode must be used, use a pulse stretching circuit to detect high narrow pulse widths down to 500ns and stretch them to the visible width (e.g., >50ms). The following Electronic Design web link article has a sample pulse stretching circuit:

Use the Input high / Output high configuration, as shown in Figure 2 from the Electronic Design link. The output high stretch time is set by the time constant ( $R1 * C1$ ).

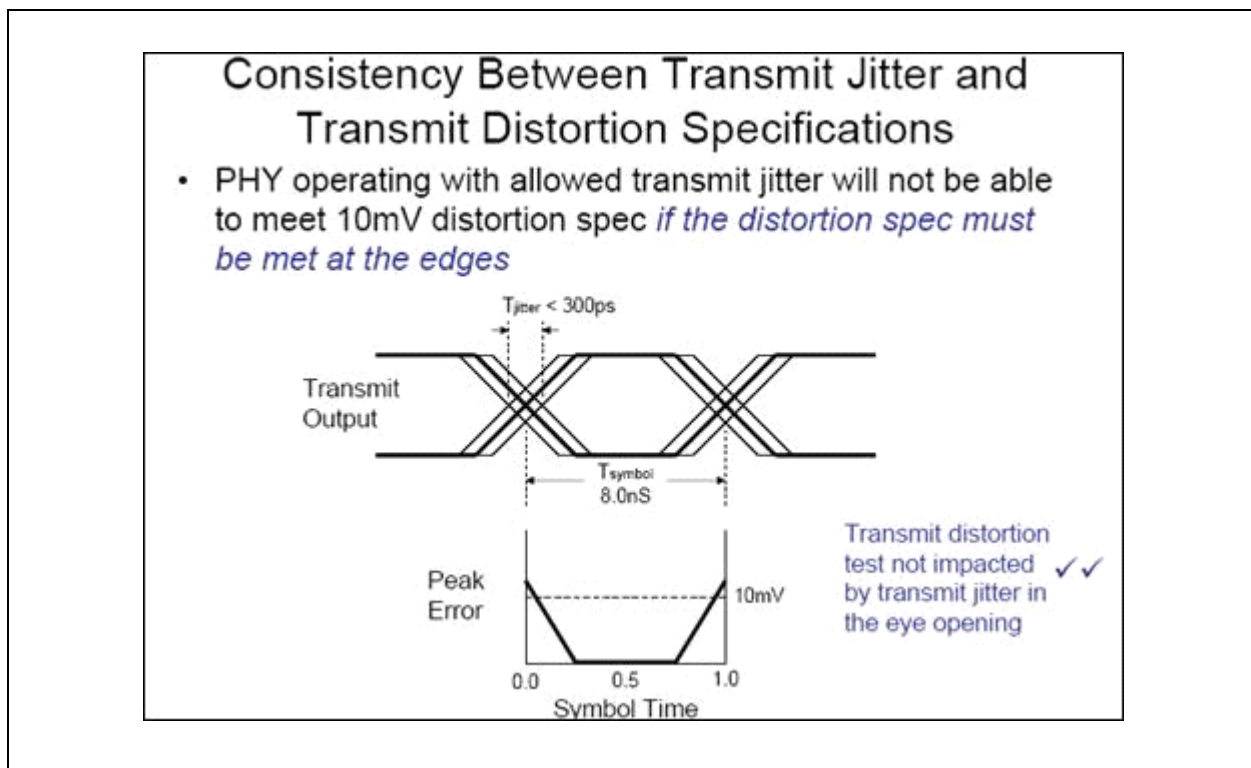
**FIGURE 3: IEEE DOCUMENT PAGE 6**

The device's 1000BASE-T Transmitter Distortion is in the 8-20mV range, versus the <10mV indicated in the IEEE specification.

IEEE testing calls for <10mV peak transmitter distortion for at least 60% of the UI within the eye opening. However, this measurement might not be valid, as the transmit distortion test is sensitive to transmit jitter. Refer to the explanation below, taken from the aforementioned IEEE document.

- On page 6, a contradiction between Transmit Jitter and Transmit Distortion requirements:
