# ES\_LPC1850/30/20/10

Errata sheet LPC1850, LPC1830, LPC1820, LPC1810

Rev. 7.2 — 20 September 2019

Errata sheet

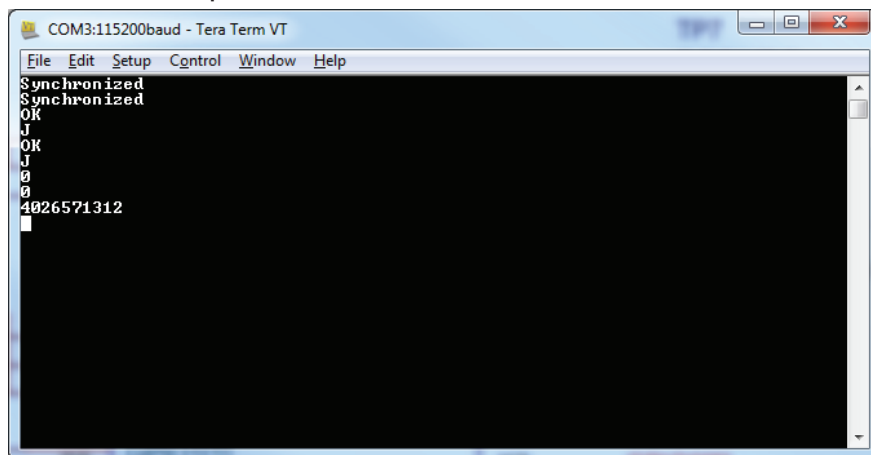
#### Incorrect example:

#### Problem:

The 'J' command in ISP mode should return an error code, followed by an ASCII string representation of the part ID, followed by a 0. However what is actually returned is the error code, followed by a 0, followed by an ASCII string representation of the part ID. The problem is the last two items returned are swapped.

There is no work-around for this problem.

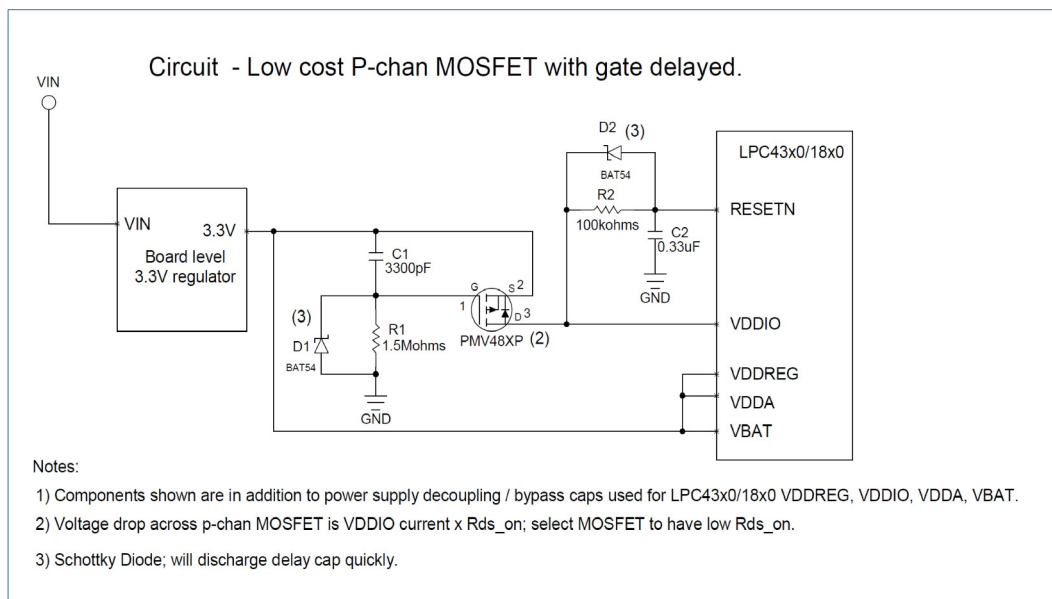
On all packages, repeated power cycling of the device may cause erroneous programming of the OTP banks. During ramp-up, the VDDREG supply voltage does not have enough time to settle and initialize the OTP controller before valid programming voltage is reached on the VPP pin. This may cause accidental programming of the OTP banks. Accidental programming of the OTP banks does not occur during Power-down of the supply voltage.

- Do not tie VDDIO to VDDREG and VDDA pins. The power supplied to the VDDIO pin should be delayed by 2 ms after the power supply on the VDDREG and VDDA pins stabilizes at the operating voltage level. The signal to the RESETN pin must also be delayed by 2 ms after the power supply on the VDDIO pin stabilizes at the operating voltage level.

The following circuit diagram is an example that shows the P-channel MOSFET with the gate delayed and the R-C delay circuit connected to the RESETN pin.

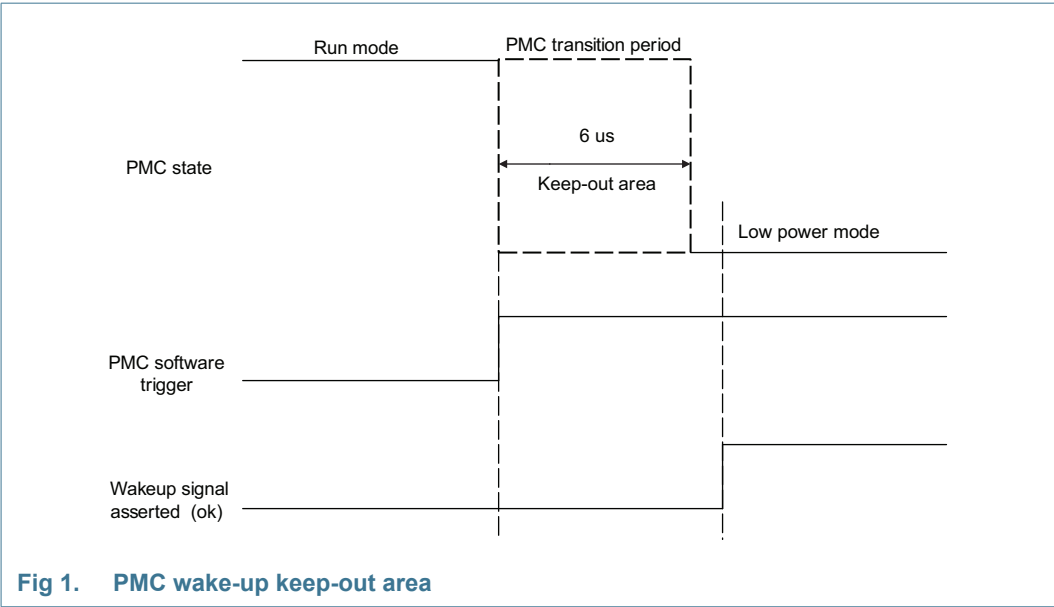
When the chip is in a transition from active to Deep Sleep, Power Down, or Deep Power Down, wake-up events are not captured and they will block further wake-up events from propagating. The time window for this transition is 6  $\mu$ S and is not affected by the chip clock speed. After a wake-up event is received during the PMC transition, the chip can only recover by using an external hardware reset or by cycling power.

Make sure that a wake-up signal is not received during the Deep Sleep, Power Down, or Deep Power Down transition period. An example circuit to work around this could include an external 6  $\mu$ S one shot which could be triggered via software using a GPIO line when entering Deep Sleep, Power Down, or Deep Power Down mode. The one-shot's output could be used to gate the wake-up signal(s) to prevent receiving a wake-up signal during the PMC transition period. Depending on the system design, it may also be needed to latch the wake-up signal(s) so that they will still be present after the one-shot's 6  $\mu$ S time-out.
