# MAX32630 ERRATA SHEET

## Revision A1 Errata

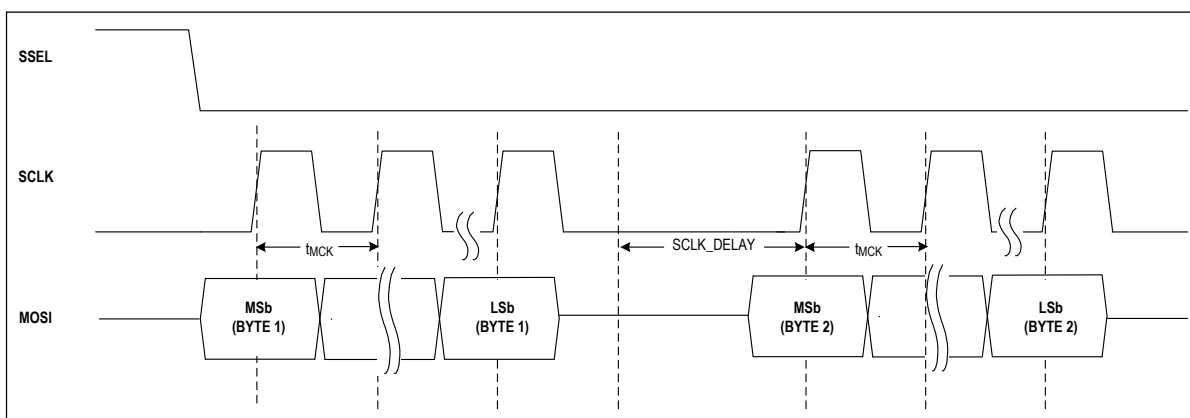
The SPI master remains low one or more SCLK cycles after transmitting 8 bits of data, resulting in an interbyte delay when transmitting back-to-back bytes. This erratum does not affect the integrity of the synchronous SPI bus because no data is clocked in or out by the SPI slave during the delay time SCLK is asserted low.

In single mode, the delay occurs after SDIO[0] has transmitted all eight bits.

In dual mode, the delay occurs after SDIO[1:0] have each transmitted four bits.

In quad mode, the delay occurs after SDIO[3:0] have each transmitted two bits.

The length of the delay is a function of the SPI clock frequency as shown in the following table. The SPI master must be operated in sample mode with a maximum frequency of 24MHz.

None.
