# MAX32630 ERRATA SHEET

## Revision A2 Errata

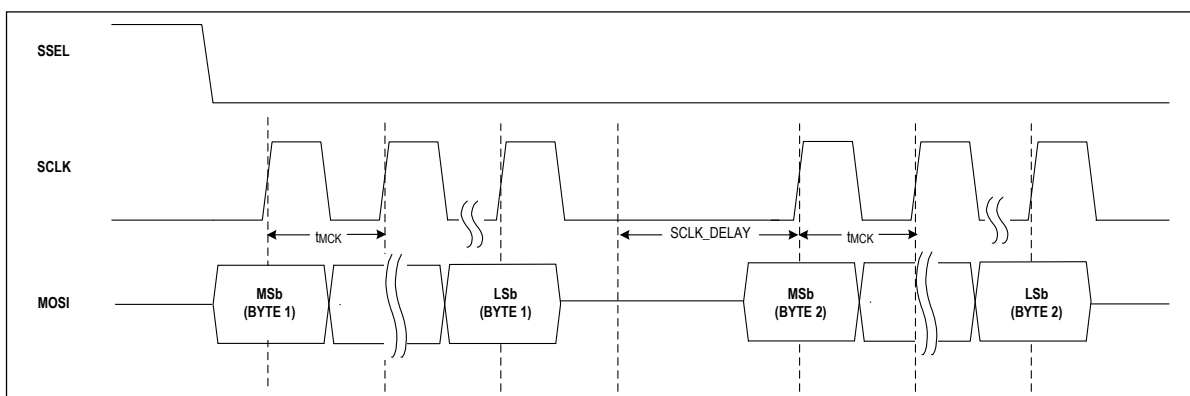
The SPI master remains low one or more SCLK cycles after transmitting 8 bits of data, resulting in an interbyte delay when transmitting back-to-back bytes. This erratum does not affect the integrity of the synchronous SPI bus because no data is clocked in or out by the SPI slave during the delay time SCLK is asserted low.

In single mode, the delay occurs after SDIO[0] has transmitted all 8 bits.

In dual mode, the delay occurs after SDIO[1:0] have each transmitted 4 bits.

In quad mode, the delay occurs after SDIO[3:0] have each transmitted 2 bits.

The length of the delay is a function of the SPI clock frequency as shown in the following table. The SPI master must be operated in sample mode with a maximum frequency of 24MHz.

None.
