## MCP98242 Rev. A1 Silicon Errata

The MCP98242 family devices that you have received conform functionally to the current Device Data Sheet (DS21996B), except for the anomalies described in this document.

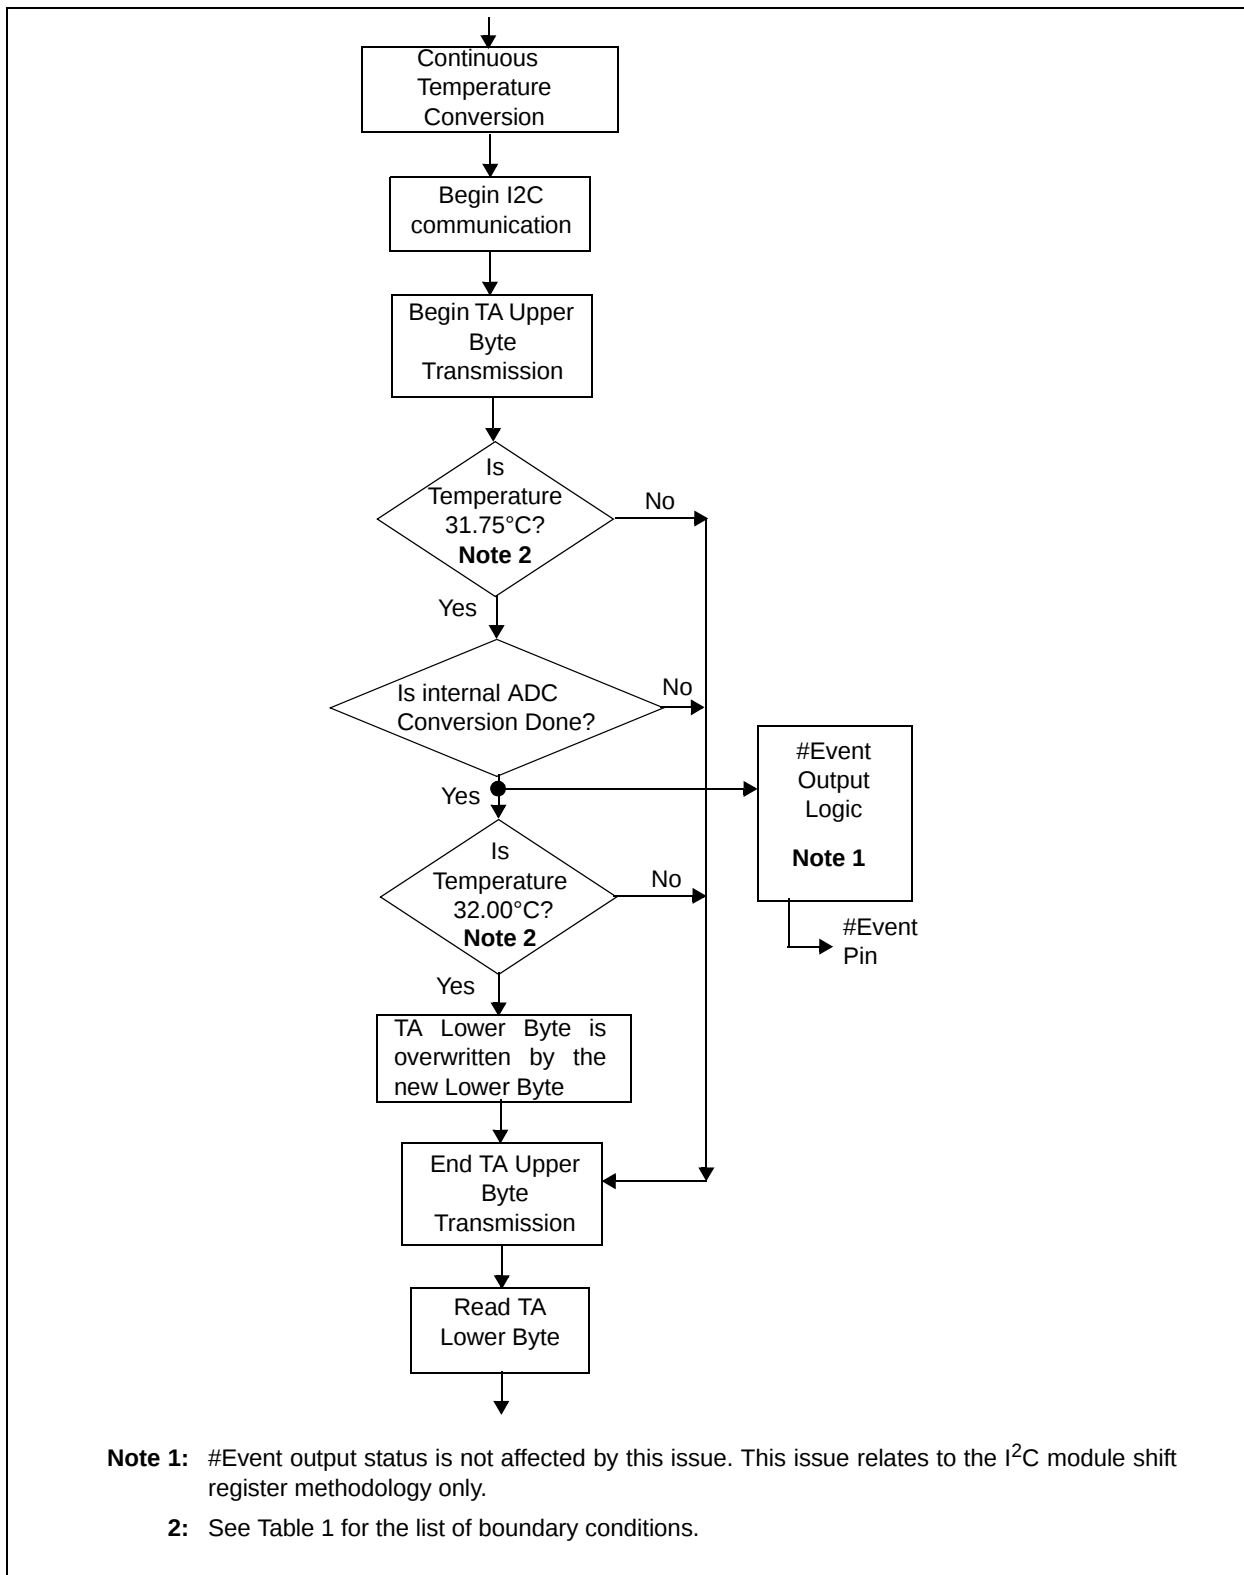
**FIGURE 1:** Flow Chart.

Under the specific boundary conditions listed below, the 2 byte temperature register  $T_A$  may contain temperature data  $+16^\circ\text{C}$  or  $-16^\circ\text{C}$  from the nominal temperature due to internal data synchronization issue.

- a) If the Lower Byte of the  $T_A$  register rolls up or down:
  - from '1111 1100'b to '0000 0000'b
  - from '0000 0000'b to '1111 1100'b
- b) If the internal ADC conversion completes ( $T_{\text{CONV}} = 65 \text{ ms}$ ) while the Upper Byte is in transmission via the  $I^2\text{C}$  bus.

Under these two conditions, the temperature reading may jump up or down by  $16^\circ\text{C}$ .

Byte 1 must be in  $I^2\text{C}$  transmission for this issue to occur and the ADC must complete conversion while  $I^2\text{C}$  is in communication. In addition, the ambient temperature must be at multiples of  $16^\circ\text{C} \pm 0.25^\circ\text{C}$  for the temperature register to be partially overwritten.

Figure 1 shows flow diagram describing the specific conditions for the synchronization issue occurs. Table 1 shows a complete list of temperatures greater than 0°C.

If the ambient temperature read is within the host temperature limit, then do nothing. Otherwise, if the new temperature read is greater than or less than the previous temperature data by exactly 16.00°C, then perform a Repeat Read to receive the correct temperature data. There is a 0% probability that the Repeat Read data would be corrupted, if the Repeat Read is performed within T<sub>CONV</sub> (65 ms). If a Repeat Read is performed after 65 ms then there is a greater than 0% probability that the next conversion would also be corrupt by ±16.00°C as stated in Table 1. In this case, disregard this reading and perform a Repeat Read and compare the result with the last known good reading.

Devices on or after date code 0847 correct this issue. **The Device ID/Revision Register for these parts is set to 0x2000 hex.**
