## MEC170x Silicon Errata and Data Sheet Clarification

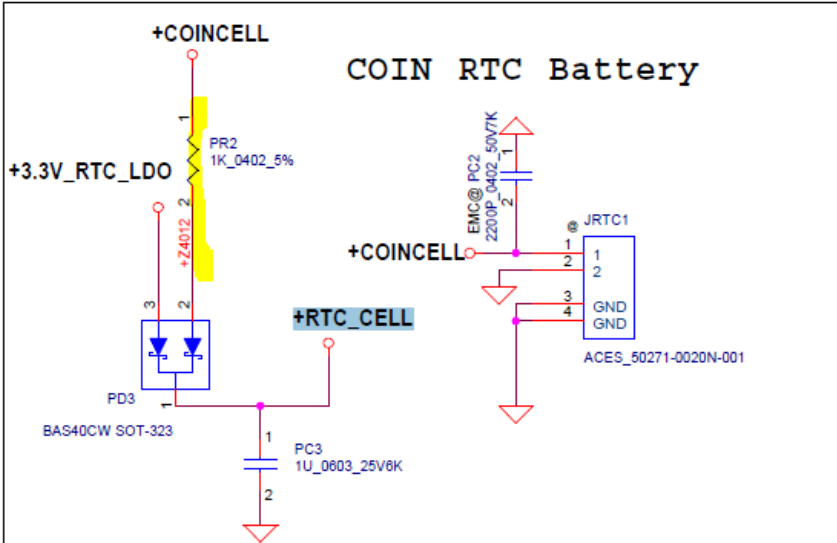
There could be a high  $I_{BAT}$  current on new coin cell insertion. During initial VBAT power rising, the VBAT circuit can enter a high current state causing a voltage drop across the 1K UL resistor. This affects all 128 and 144 pin packages. This issue is not present in the 169 pin packages.

- Under these conditions, the VBAT power on can stall in this high current state, with the VBAT on device pin between 0.7 and 1.2V.

Insert the coin cell and then apply VTR (i.e +3VALW). This enables VBAT low-power operation. A high  $I_{BAT}$  will not return on subsequent VTR power cycles.

Referring to the RTC Battery circuit shown in [Figure 1](#), applying VTR via the +3.3V\_RTC\_LDO signal, powers RTC\_Cell (which is connected to VBAT of MEC5105/6) directly (without a series 1k resistor and hence no IR drop from the applied VTR), raising VBAT (RTC\_Cell) to greater than 2.0 volts. This takes VBAT out of the "high current" region discussed above enabling normal VBAT low power operation.
