## MSP430F2132 Device Erratasheet

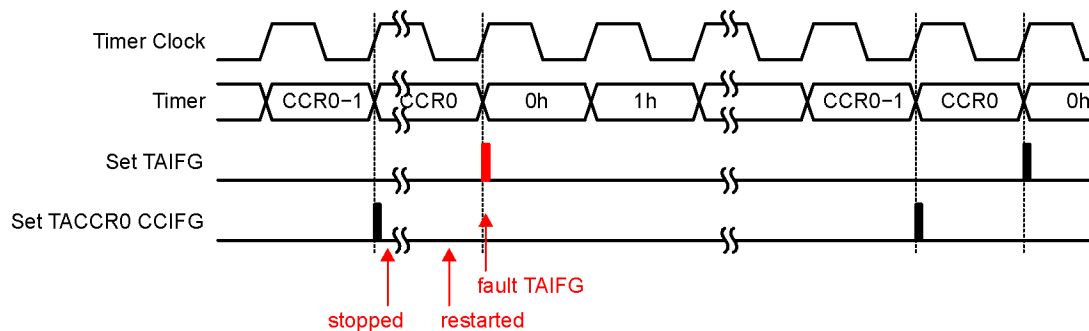
## TA21 *TIMER\_A Module*

**Function** TAIFG Flag is erroneously set after Timer A restarts in Up Mode

**Description** In Up Mode, the TAIFG flag should only be set when the timer counts from TACCR0 to zero. However, if the Timer A is stopped at TAR = TACCR0, then cleared (TAR=0) by setting the TACLRL bit, and finally restarted in Up Mode, the next rising edge of the TACLK will erroneously set the TAIFG flag.

**Workaround** None.
