## **MSP430F4152 Device Erratasheet**

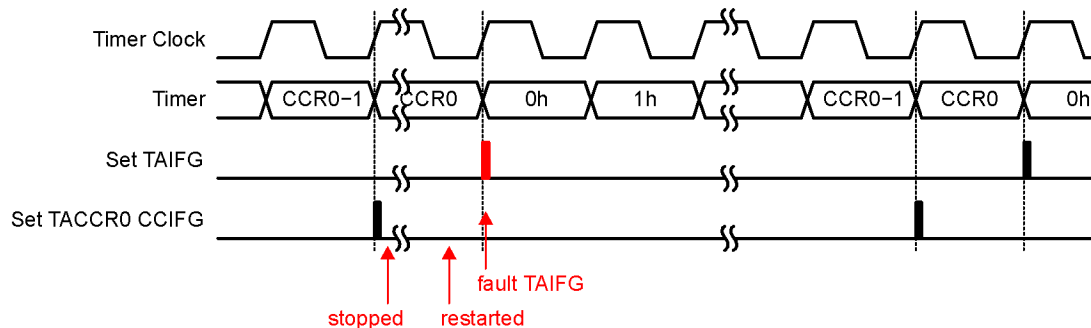
## TA21

TAIFG Flag is erroneously set after Timer A restarts in Up Mode

In Up Mode, the TAIFG flag should only be set when the timer counts from TACCR0 to zero. However, if the Timer A is stopped at TAR = TACCR0, then cleared (TAR=0) by setting the TACLR bit, and finally restarted in Up Mode, the next rising edge of the TACLK will erroneously set the TAIFG flag.

None.
