## MSP430F5324 Device Erratasheet

The revision of the device can be identified by the revision letter on the [Package Markings](#) or by the [HW\\_ID](#) located inside the TLV structure of the device

## 7 Detailed Bug Description

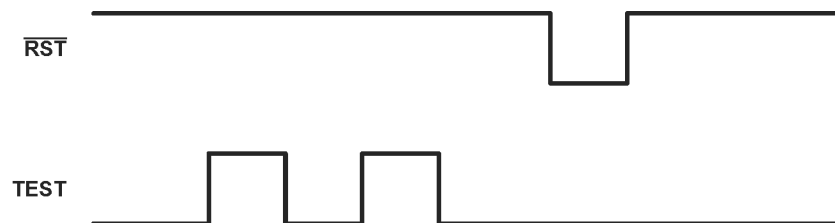
| <b>Description</b> | The methods used to exit the BSL per MSP430 Programming Via the Bootstrap Loader (SLAU319) are invalid. |

| <b>Workaround</b> | To exit the BSL one of the following methods must be used.<br>- A Power cycle<br>or<br>- Toggle the TEST pin twice when nRST is high and after 50us pull nRST low. |

Note: This toggling of TEST pins is not subject to timing constraints. The appropriate level transitions on TEST pin, followed by a RST pulse after 50us, are sufficient to trigger an exit from BSL mode.
