## MSP430F5333 Device Erratasheet

The revision of the device can be identified by the revision letter on the [Package Markings](#) or by the [HW\\_ID](#) located inside the TLV structure of the device

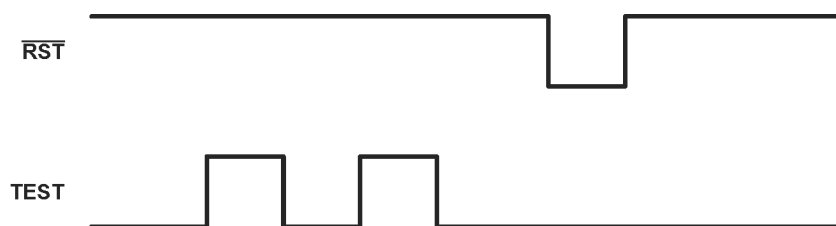
To exit the BSL one of the following methods must be used.

- A Power cycle
- or
- Toggle the TEST pin twice when nRST is high and after 50us pull nRST low.

Note: This toggling of TEST pins is not subject to timing constraints. The appropriate level transitions on TEST pin, followed by a RST pulse after 50us, are sufficient to trigger an exit from BSL mode.
