## MSP430F5436A Device Erratasheet

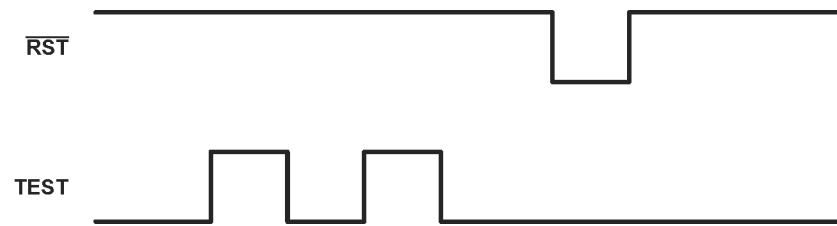
- A Power cycle

- or
- Toggle the TEST pin twice when nRST is high and after 50us pull nRST low.

Note: This toggling of TEST pins is not subject to timing constraints. The appropriate level transitions on TEST pin, followed by a RST pulse after 50us, are sufficient to trigger an exit from BSL mode.

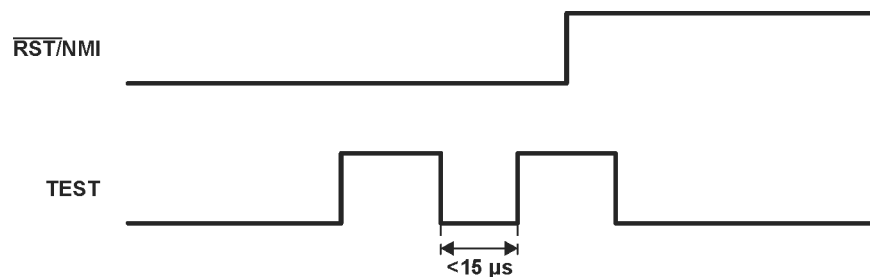
| <b>Function</b> | BSL entry sequence is subject to specific timing requirements |
| <b>Description</b> | <p>The BSL entry sequence requires that the low phase of the TEST/SBWTCK pin does not exceed 15us. This timing requirement is faster than most PC serial ports can provide, as shown in the following picture. If this requirement is not met, the entry sequence fails and the SYSBSLIND is not set.</p> |

| <b>Workaround</b> | An external hardware solution is recommended to provide the appropriate BSL entry sequence. See <a href="http://processors.wiki.ti.com/index.php/BSL_(MSP430)">http://processors.wiki.ti.com/index.php/BSL_(MSP430)</a> for recommendations on available BSL hardware. |
