## MSP430FG437 Device Erratasheet

### 1 Functional Errata Revision History

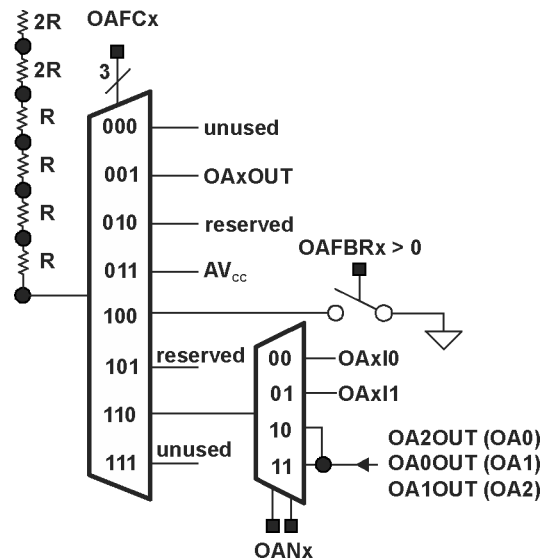
## OAx11 input selection

Referring to the OA block diagram in the MSP430x4xx User's Guide, the internal connection of the OAxI1 input to the OAFx mux is incorrect. The signal input to the OAFx mux when OANx = 01 is OA0I1 for all OAs. See the figure below for a graphical representation.

None

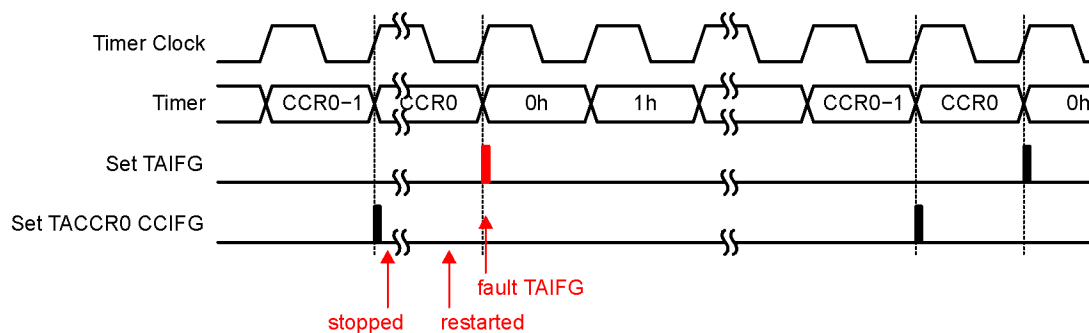
## TA21 *TIMER\_A Module*

**Function** TAIFG Flag is erroneously set after Timer A restarts in Up Mode

**Description** In Up Mode, the TAIFG flag should only be set when the timer counts from TACCR0 to zero. However, if the Timer A is stopped at TAR = TACCR0, then cleared (TAR=0) by setting the TACLRL bit, and finally restarted in Up Mode, the next rising edge of the TACLK will erroneously set the TAIFG flag.

**Workaround** None.

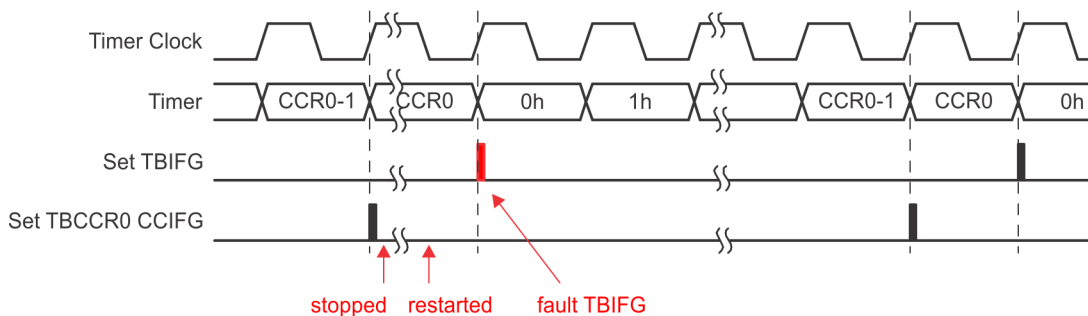
| <b>Function</b> | TBIFG Flag is erroneously set after Timer B restarts in Up Mode |
| <b>Description</b> | <p>In Up Mode, the TBIFG flag should only be set when the timer resets from TBCCR0 to zero. However, if the Timer B is stopped at TBR = TBCCR0, then cleared (TBR=0) by setting the TBCLR bit, and finally restarted in Up Mode, the next rising edge of the TBCLK will erroneously set the TBIFG flag.</p> |

| <b>Workaround</b> | None. |
