## MSP430FG4616 Device Erratasheet

### 1 Functional Errata Revision History

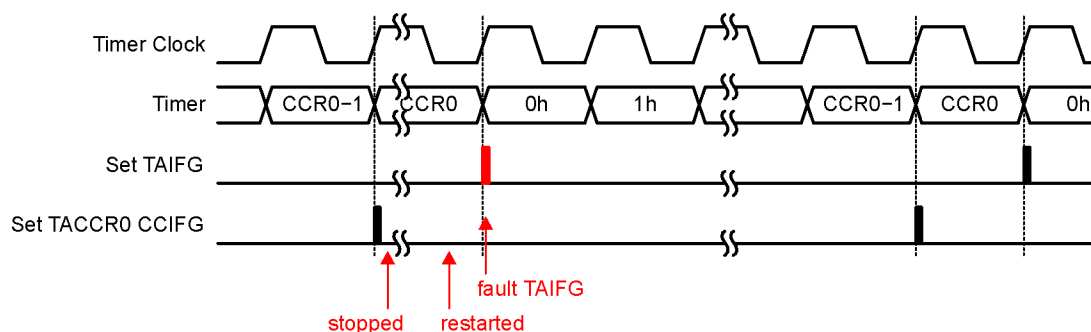
**Function** TAIFG Flag is erroneously set after Timer A restarts in Up Mode

**Description** In Up Mode, the TAIFG flag should only be set when the timer counts from TACCR0 to zero. However, if the Timer A is stopped at TAR = TACCR0, then cleared (TAR=0) by setting the TACLR bit, and finally restarted in Up Mode, the next rising edge of the TACLK will erroneously set the TAIFG flag.

**Workaround** None.

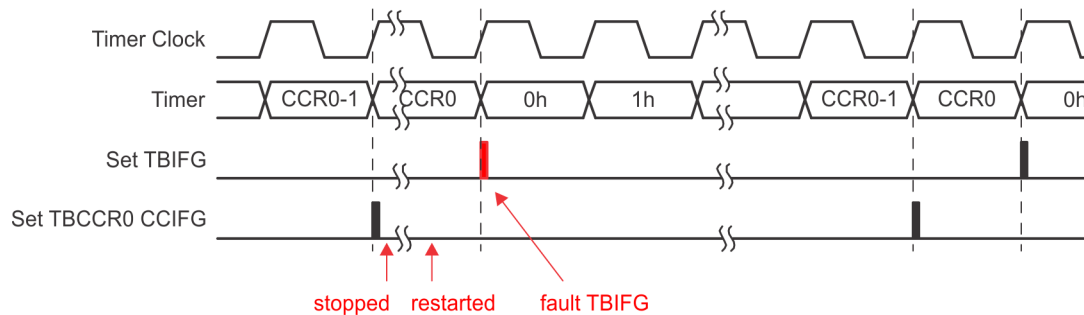
TBIFG Flag is erroneously set after Timer B restarts in Up Mode

In Up Mode, the TBIFG flag should only be set when the timer resets from TBCCR0 to zero. However, if the Timer B is stopped at TBR = TBCCR0, then cleared (TBR=0) by setting the TBCLR bit, and finally restarted in Up Mode, the next rising edge of the TBCLK will erroneously set the TBIFG flag.

None.
