## MSP430G2112 Device Erratasheet

### 1 Functional Errata Revision History

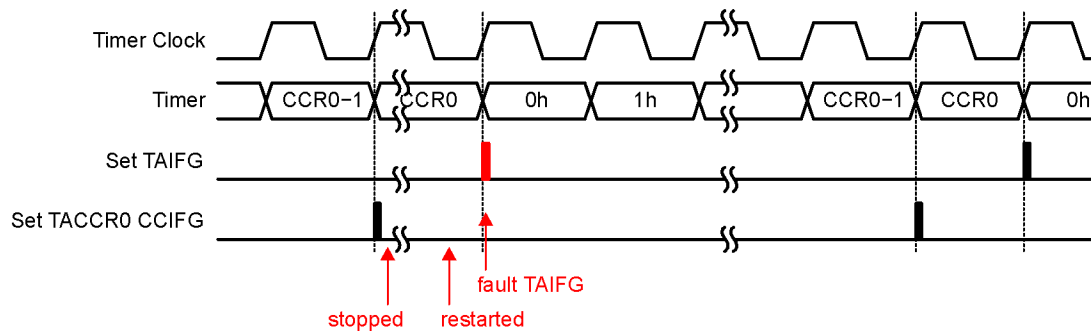
## TA21

**Function** TAIFG Flag is erroneously set after Timer A restarts in Up Mode

**Description** In Up Mode, the TAIFG flag should only be set when the timer counts from TACCR0 to zero. However, if the Timer A is stopped at TAR = TACCR0, then cleared (TAR=0) by setting the TACLR bit, and finally restarted in Up Mode, the next rising edge of the TACLK will erroneously set the TAIFG flag.

**Workaround** None.
