## **MSP432E4 SimpleLink™ Microcontrollers**

### **1 Introduction**

This document describes known exceptions to the functional specifications for the SimpleLink™ MSP432E4 microcontrollers. Note that some features are not available on all devices in the series, so not all errata may apply to your device. See your device-specific data sheet for more details.

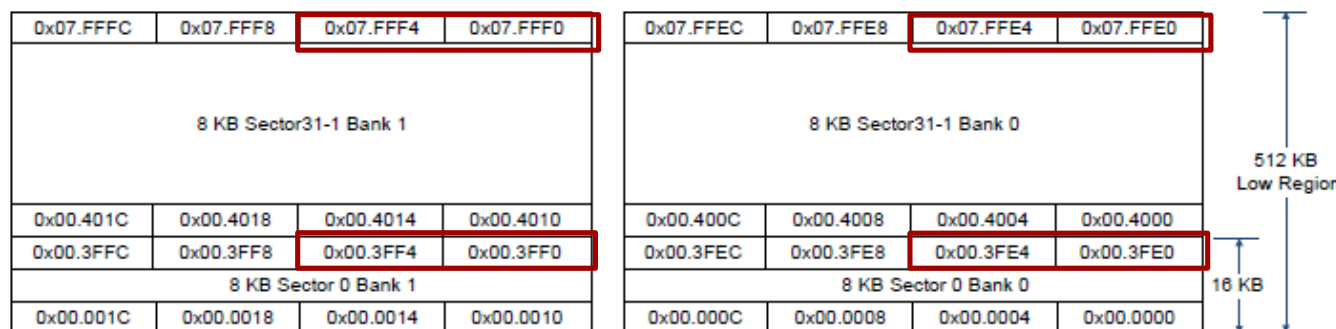
## MEM#15 *Specific flash locations in any sector do not get erased*

If only one or both of the first two words of the last line of a sector in a bank are programmed, an Erase of entire Sector, Mass Erase of device, or toggle mass erase does not erase the flash back to all 1's. The diagram below shows the affected words in Sector 0 and Sector 31 of the lower 512KB of Flash.

Program any other word in the Sector-Bank to allow Sector Erase to work.

**NOTE:** Toggle Mass Erase or Mass Erase will still not work.
