# OMAP-L132 C6000™ DSP+ARM® Processor Silicon Revisions 2.3, 2.1

## Silicon Errata

Literature Number: SPRZ317G  
August 2011–Revised March 2014

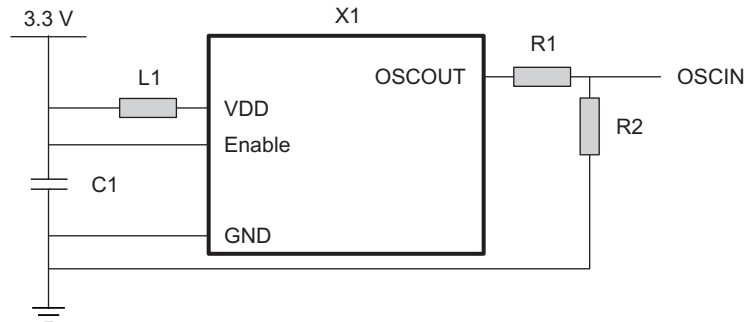
**Figure 2. External 3.3V Clock Source**

On all silicon revisions, certain design elements make this device susceptible to radiated noise during an ESD strike, as described in the standard IEC 61000-4-2. Exposure to the electrical noise caused by the ESD can cause soft device failures due to noise coupling on the system clock (OSCIN). ESD events within the IEC spec range do not cause permanent device damage and full functionality is recoverable with a device reset. The sensitivity to this noise issue is primarily due to the 1.2V oscillator/clock input implemented on this device. The low voltage range, coupled with slow rise and fall times, provides a lower noise margin than other TI devices with higher voltage internal oscillators (for example, 1.8V or 3.3V oscillators).

If ESD robustness is a concern, it is strongly recommended to avoid using the internal oscillator as a clock source. An external 3.3V clock source with a resistor voltage divider as in [Figure 2](#) can be used to externally generate the required 1.2V input clock. By using an external clock input with fast rise/fall times (less than 5 ns), the noise margin improves significantly, increasing ESD noise resistance.

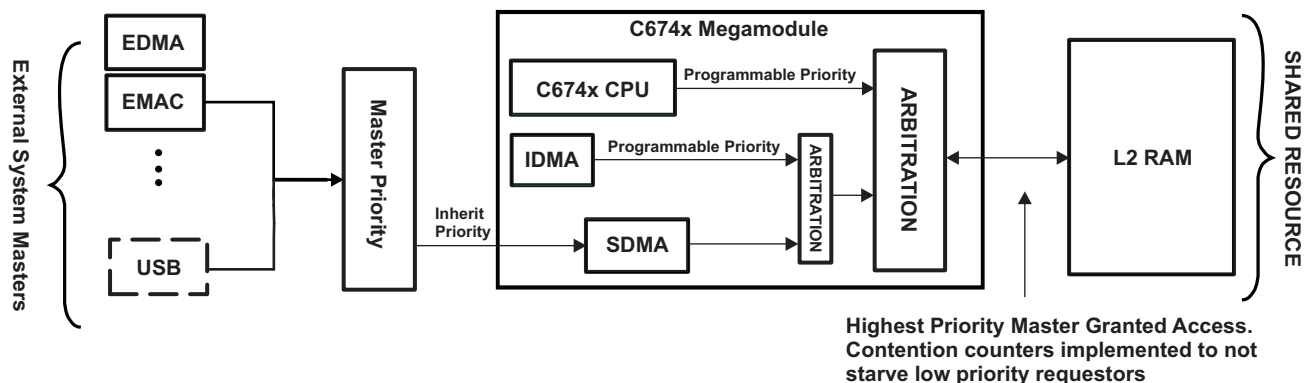
**Figure 3. Priority Arbitration Scheme for L2 RAM**

Ideally, the BWM arbitration will grant equal L2 bandwidth between equal priority DMA and CPU requests. Instead, when equal priority DMA and CPU requests arrive at the BWM, bandwidth is always granted in favor of the CPU over DMA. In the case of successive CPU requests, it is possible for the CPU to block all DMA requests until CPU traffic subsides. Additionally, some command logic in the BWM uses priority level 7, which can also result in SDMA stalls when the CPU is also programmed to priority level 7. [Figure 3](#) shows a high level diagram of the arbitration scheme used for L2 RAM requests.

**Workaround(s)** Configure DMA and CPU requests to different priority levels. There is no penalty for setting the IDMA and SDMA priorities equal to each other.

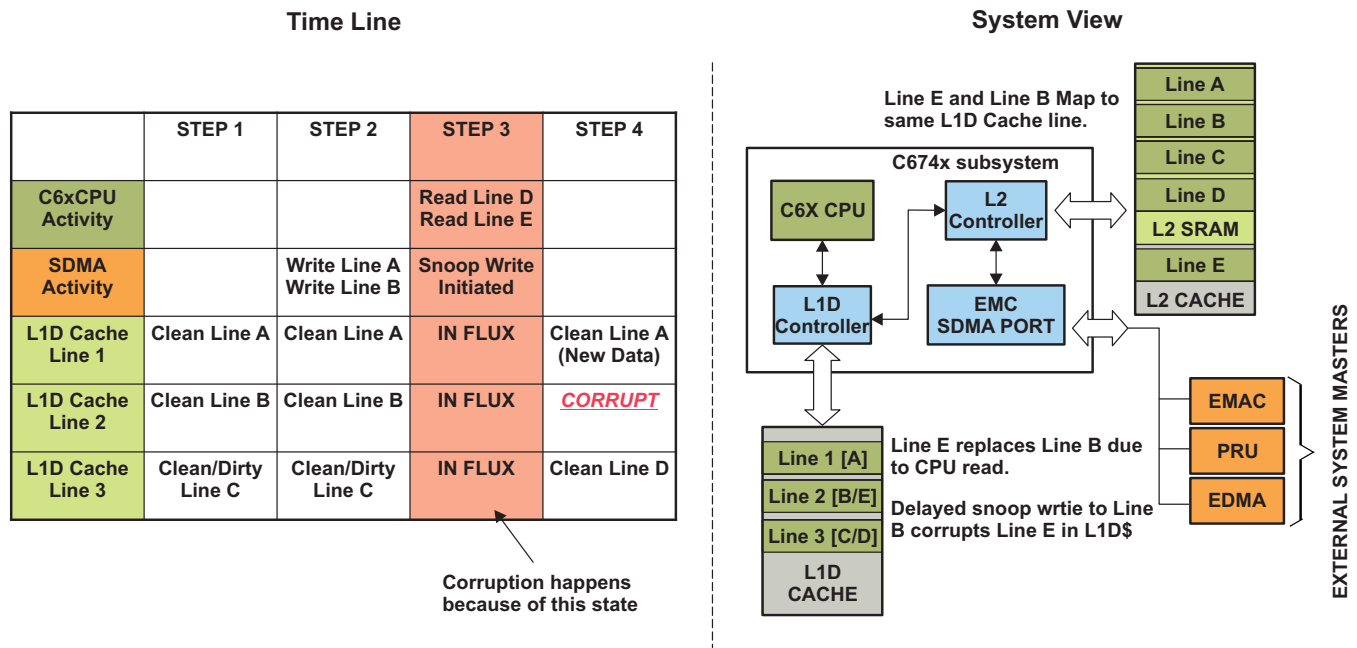
**Figure 4. Example of L1D Cache Corruption**

- Line E in L2 cache is read as a cache hit. Line E is destined to replace Line 2 in L1D Cache, which also has a snoop write pending for the updated Line B content.

- Line D in L2 SRAM is read. Line D will replace Line 3 in L1D cache.
4. When the snoop write operation completes, Line 2 in L1D cache now contains the updated L2 SRAM Line B data instead of the L2 cache Line E data.

The correct behavior would have been to kill the pending snoop write initiated to update L1D cache Line 2 with the updated L2 SRAM Line B data in Step 3. The L1D cache should have evicted Line B and replaced it with Line E data. Instead, the snoop write operation continues and does not complete until after the L1D cache Line 2 has already been replaced with L2 cache Line E data. The snoop write instruction overwrites the L1D cache Line 2 (containing L2 cache Line E data) with the updated L2 SRAM Line B data.
