## PIC16(L)F1934/1936/1937 Family Silicon Errata and Data Sheet Clarification

The PIC16(L)F1934/1936/1937 family devices that you have received conform functionally to the current Device Data Sheet (DS41364E), except for the anomalies described in this document.

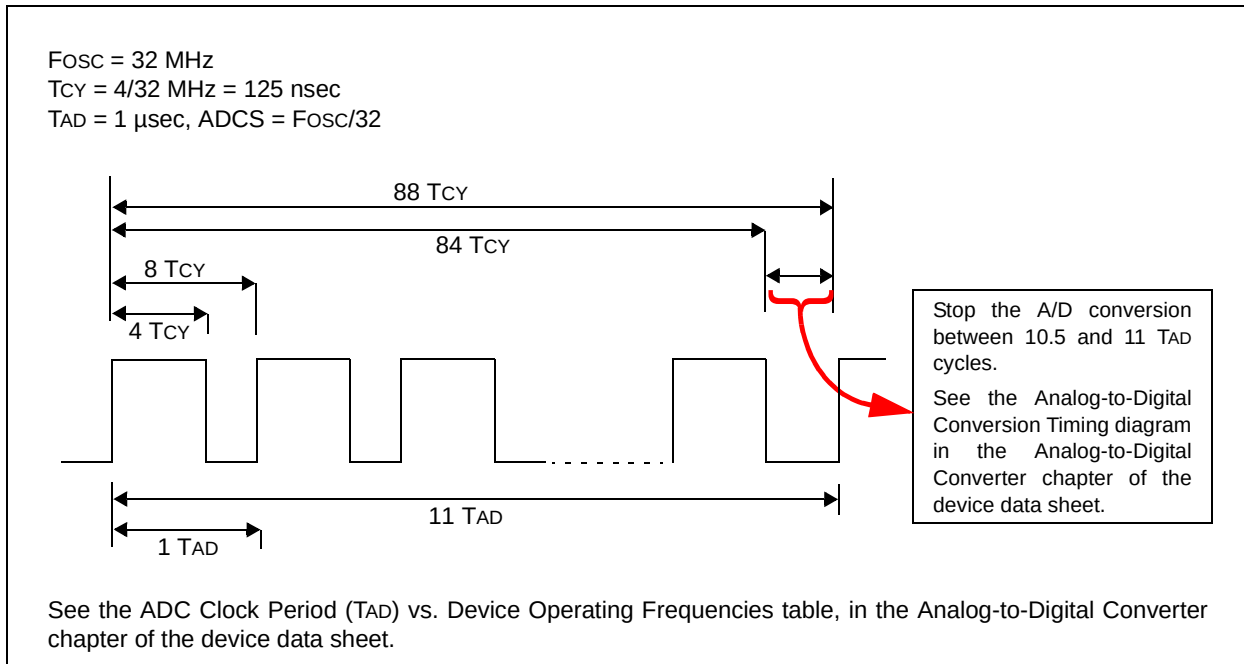
**FIGURE 1: INSTRUCTION CYCLE DELAY CALCULATION EXAMPLE**

An ADC conversion may not complete under these conditions:

1. When  $F_{osc}$  is greater than 8 MHz and it is the clock source used for the ADC converter.
2. The ADC is operating from its dedicated internal FRC oscillator and the device is not in Sleep mode (any  $F_{osc}$  frequency).

When this occurs, the ADC Interrupt Flag (ADIF) does not get set, the GO/DONE bit does not get cleared, and the conversion result does not get loaded into the ADRESH and ADRESL result registers.

In [Figure 1](#), 88 instruction cycles (Tcy) will be required to complete the full conversion. Each TAD cycle consists of 8 Tcy periods. A fixed delay is

provided to stop the A/D conversion after 86 instruction cycles and terminate the conversion at the correct time as shown in the figure above.

**Note:** The exact delay time will depend on the TAD divisor (ADCS) selection. The Tcy counts shown in the timing diagram above apply to this example only. Refer to [Table 3](#) for the required delay counts for other configurations.

Method 3: This method is provided if the application cannot use Sleep mode and requires continuous operation at frequencies above 8 MHz. This method requires early termination of an ADC conversion. Provide a fixed time delay in software to stop the A-to-D conversion manually, after all 10 bits are converted, but before the conversion would complete automatically. The conversion is stopped by clearing the GO/DONE bit in software. The GO/DONE bit must be cleared during the last  $\frac{1}{2}$  TAD cycle, before the conversion would have completed automatically. Refer to [Figure 1](#) for details.
