# MICROCHIP PIC12(L)F1822/PIC16(L)F1823

## PIC12(L)F1822/PIC16(L)F1823 Family Silicon Errata and Data Sheet Clarification

The PIC12(L)F1822/PIC16(L)F1823 family devices that you have received conform functionally to the current Device Data Sheet (DS40001413E), except for the anomalies described in this document.

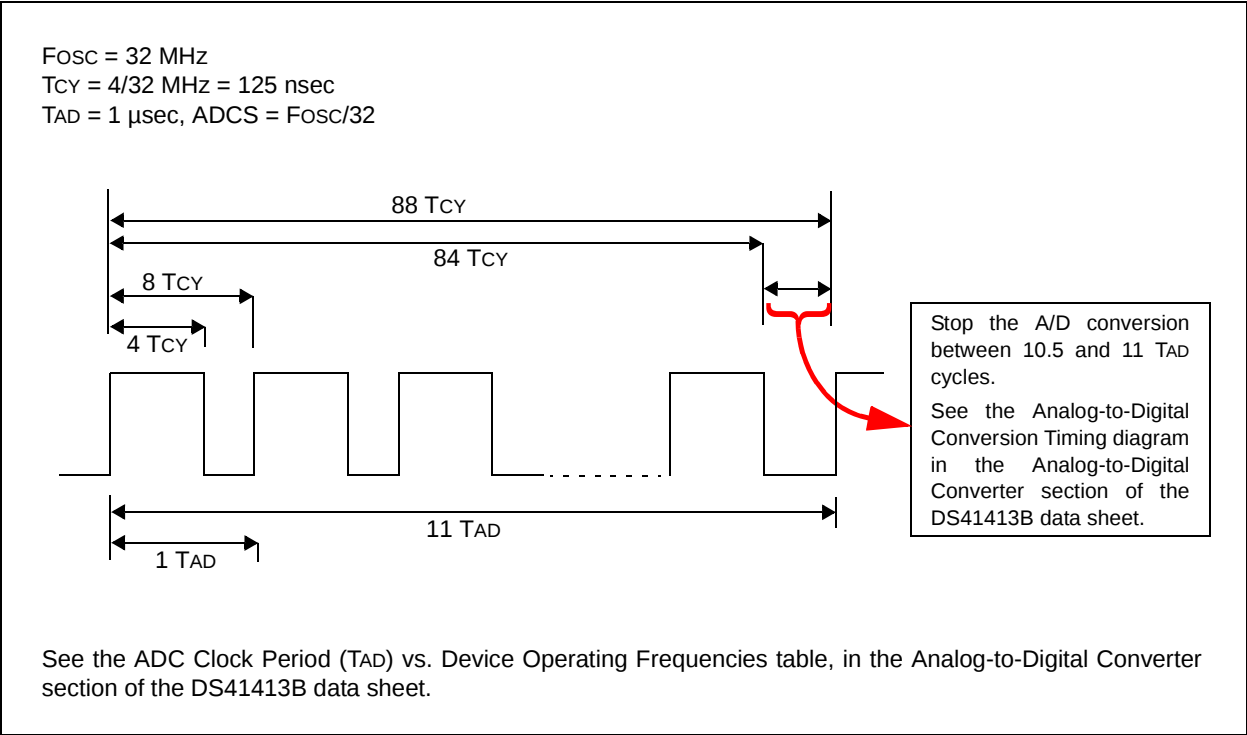
**FIGURE 1: INSTRUCTION CYCLE DELAY CALCULATION EXAMPLE**

Under certain device operating conditions, the ADC conversion may not complete properly. When this occurs, the ADC Interrupt Flag (ADIF) does not get set, the GO/DONE bit does not get cleared and the conversion result does not get loaded into the ADRESH and ADRESL result registers.

In [Figure 1](#), 88 instruction cycles (TCY) will be required to complete the full conversion. Each TAD cycle consists of 8 TCY periods. A fixed delay is provided to stop the A/D conversion after 86 instruction cycles and terminate the conversion at the correct time as shown in the figure above.

**Note:** The exact delay time will depend on the choice of FOSC and the TAD divisor (ADCS) selection. The TCY counts shown in the timing diagram above apply to this example only. Refer to [Table 3](#) for the required delay counts for other configurations.

Method 2: Provide a fixed delay in software to stop the A-to-D conversion manually, after all 10 bits are converted, but before the conversion would complete automatically. The conversion is stopped by clearing the GO/DONE bit in software. The GO/DONE bit must be cleared during the last ½ TAD cycle, before the conversion would have completed automatically. Refer to [Figure 1](#) for details.
