## PIC12F508/509 Rev. B0 Silicon/Data Sheet Errata

The PIC12F508/509 parts you have received conform functionally to the Device Data Sheet (DS41236E), except for the anomalies described below.

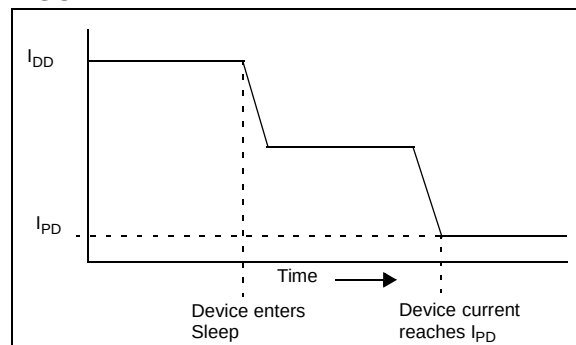
**FIGURE 1:**

On the PIC12F508/509 silicon, revisions earlier than A3, the power-down base current may remain higher than the specification for a short time when entering Sleep.

The following graph illustrates the device current upon entering Sleep:

The length of time between the device entering Sleep mode and the device current reaching  $I_{PD}$  increases as both temperature and voltage decrease.

This issue is fixed in Revisions A3 and later.
