## PIC16(L)F1824/1828 Family Silicon Errata and Data Sheet Clarification

The PIC16(L)F1824/1828 family devices that you have received conform functionally to the current Device Data Sheet (DS40001419E), except for the anomalies described in this document.

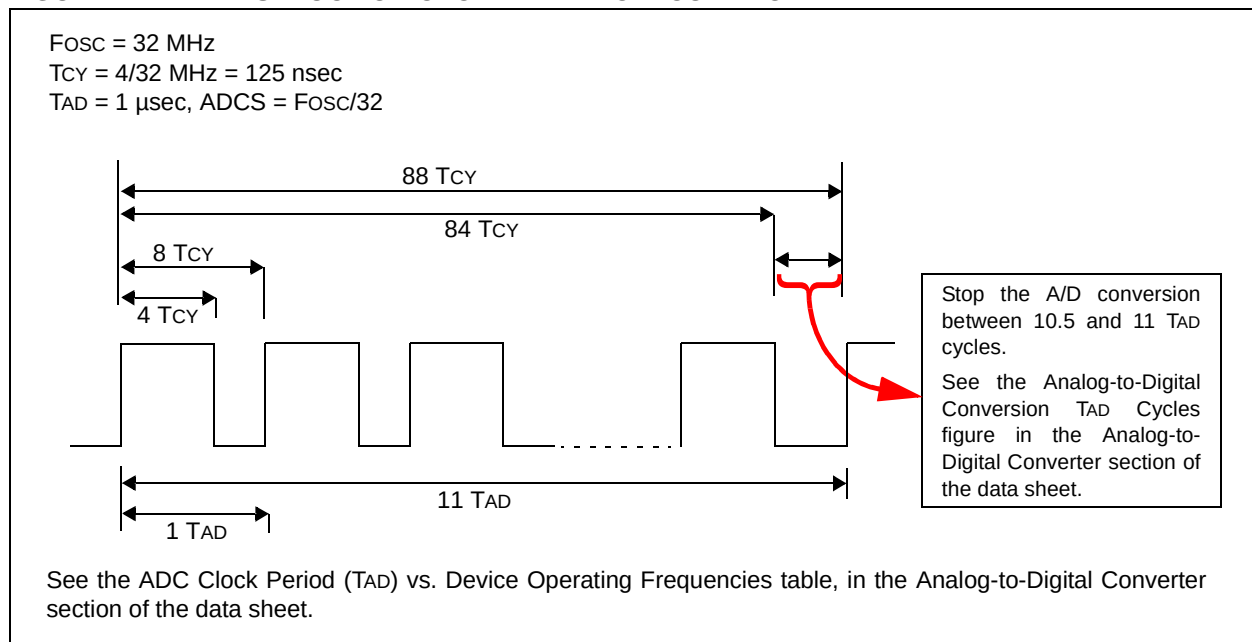
**FIGURE 1: INSTRUCTION CYCLE DELAY CALCULATION EXAMPLE**

An ADC conversion may not complete under these conditions:

1. When  $F_{OSC}$  is greater than 8 MHz and it is the clock source used for the ADC converter.
2. The ADC is operating from its dedicated internal FRC oscillator and the device is not in Sleep mode (any  $F_{OSC}$  frequency).

When this occurs, the ADC Interrupt Flag (ADIF) does not get set, the  $GO/DONE$  bit does not get cleared, and the conversion result does not get loaded into the ADRESH and ADRESL result registers.

In [Figure 1](#), 88 instruction cycles (Tcy) will be required to complete the full conversion. Each TAD cycle consists of 8 Tcy periods. A fixed delay is provided to stop the A/D conversion after 86 instruction cycles and terminate the conversion at the correct time as shown in the figure above.

Method 3: This method is provided if the application cannot use Sleep mode and requires continuous operation at frequencies above 8 MHz. This method requires early termination of an ADC conversion. Provide a fixed time delay in software to stop the A-to-D conversion manually, after all 10 bits are converted, but before the conversion would complete automatically. The conversion is stopped by clearing the  $GO/DONE$  bit in software. The  $GO/DONE$  bit must be cleared during the last  $\frac{1}{2}$  TAD cycle, before the conversion would have completed automatically. Refer to Figure 1 for details.

**Note:** The exact delay time will depend on the TAD divisor (ADCS) selection. The Tcy counts shown in the timing diagram above apply to this example only. Refer to [Table 3](#) for the required delay counts for other configurations.
