## PIC16(L)F1946/1947 Family Silicon Errata and Data Sheet Clarification

The PIC16(L)F1946/1947 family devices that you have received conform functionally to the current Device Data Sheet (DS41414D), except for the anomalies described in this document.

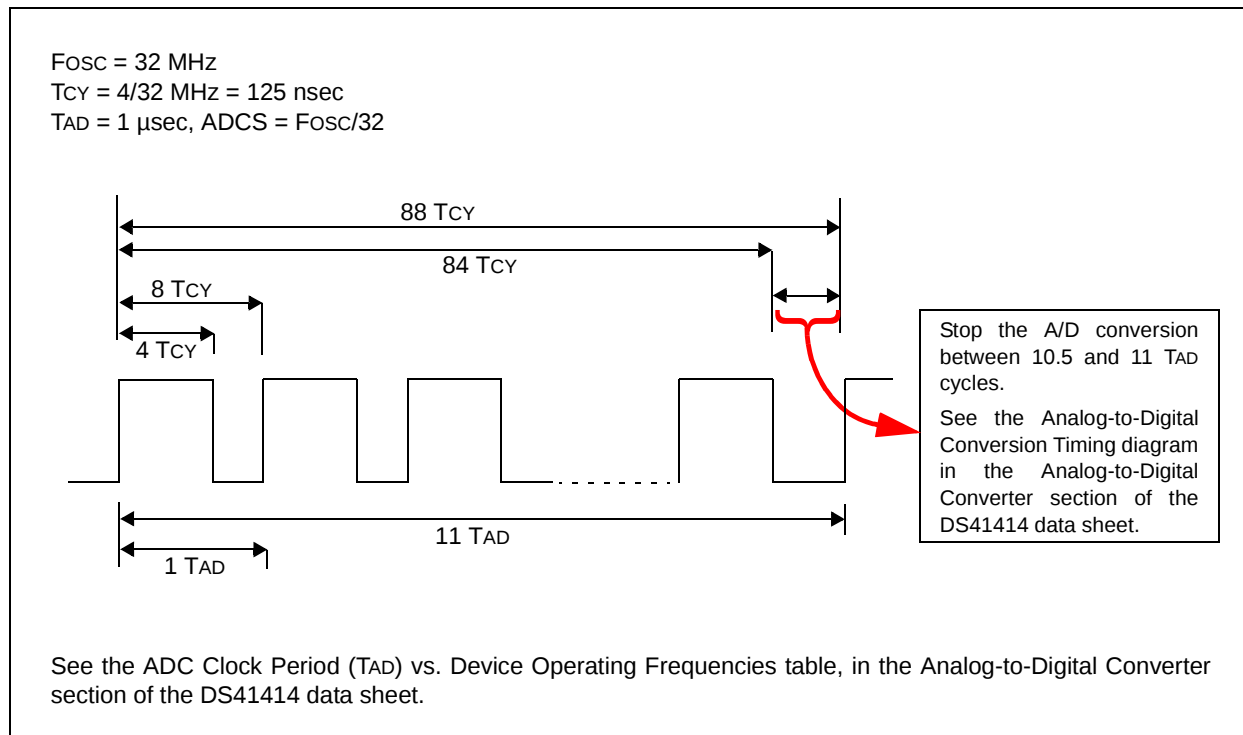
**FIGURE 1: INSTRUCTION CYCLE DELAY CALCULATION EXAMPLE**

Under certain device operating conditions, the ADC conversion may not complete properly. When this occurs, the ADC Interrupt Flag (ADIF) does not get set, the ADGO/DONE bit does not get cleared and the conversion result does not get loaded into the ADRESH and ADRESL result registers.

In Figure 1, 88 instruction cycles (Tcy) will be required to complete the full conversion. Each TAD cycle consists of eight Tcy periods. A fixed delay is provided to stop the A/D conversion after 86 instruction cycles and terminate the conversion at the correct time as shown in the figure above.

**Note:** The exact delay time will depend on the choice of Fosc and the TAD divisor (ADCS) selection. The Tcy counts shown in the timing diagram above apply to this example only. Refer to Table 3 for the required delay counts for other configurations.

Method 2: Provide a fixed delay in software to stop the A-to-D conversion manually, after all ten bits are converted, but before the conversion would complete automatically. The conversion is stopped by clearing the GO/DONE bit in software. The GO/DONE bit must be cleared during the last  $\frac{1}{2}$  TAD cycle, before the conversion would have completed automatically. Refer to [Figure 1](#) for details.
