## PIC16C924 Rev. A Silicon/Data Sheet Errata

The PIC16C924 (Rev. A) parts you have received conform functionally to the Device Data Sheet (DS30444E), except for the anomalies described below.

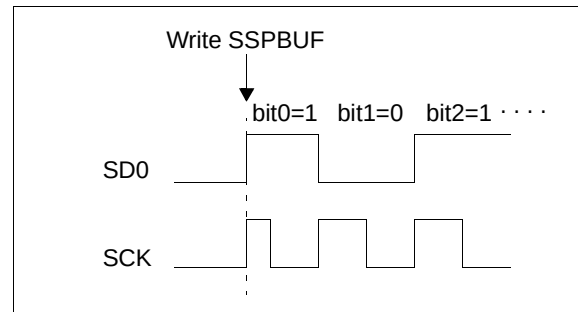
**FIGURE 1: SCK PULSE VARIATION USING TIMER 2/2**

When the SPI is using Timer2/2 as the clock source, a shorter-than-expected SCK pulse may occur on the first bit of the transmitted/received data (see Figure 1).

To avoid producing the short pulse, turn off Timer2 and clear the TMR2 register, load the SSPBUF with the data to transmit, and then turn Timer2 back on. Refer to Example 2 for sample code.

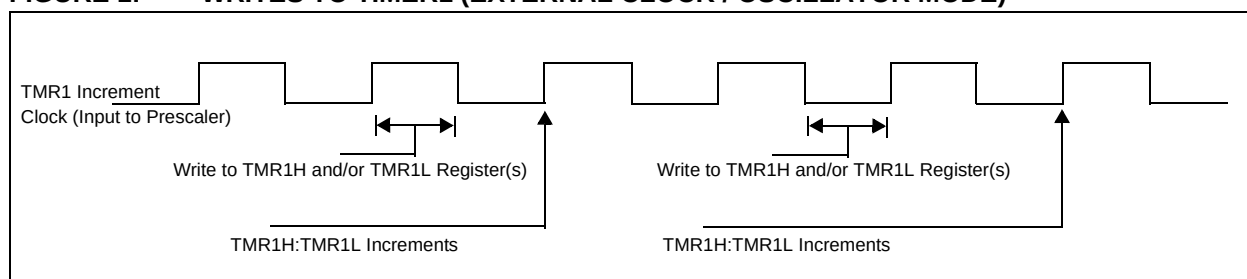
**FIGURE 1: WRITES TO TIMER1 (EXTERNAL CLOCK / OSCILLATOR MODE)**

When the TMR1H and/or TMR1L registers are written while this clock is high, TMR1 will increment on the next rising edge of this clock.

When the TMR1H and/or TMR1L registers are written while this clock is low, TMR1 will not increment on the next rising edge of this clock, but must first have a falling clock and then the rising clock for TMR1 to increment.

Figure 1 shows the two cases of writes to the TMR1H and/or TMR1L registers. Due to the  $V_{IH}$  and  $V_{IL}$  thresholds on the oscillator/clock pins, external Timer1 oscillator components, and external clock frequency, the Timer1 increment clock may not be of a 50% duty cycle.

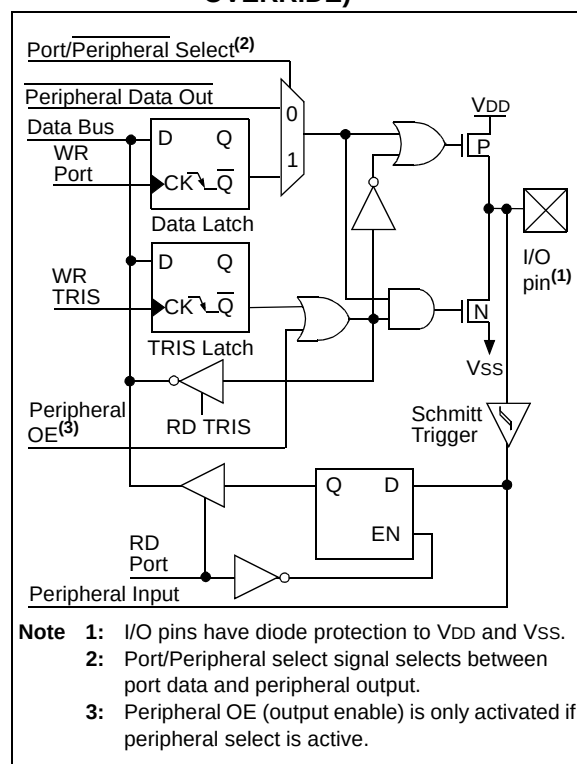
**FIGURE 2: PORTC BLOCK DIAGRAM (PERIPHERAL OUTPUT OVERRIDE)**

The block diagram for PORTC presented in Figure 5-5 of the Device Data Sheet (DS30444E) is incorrect. The correct block diagram is shown in Figure 2.

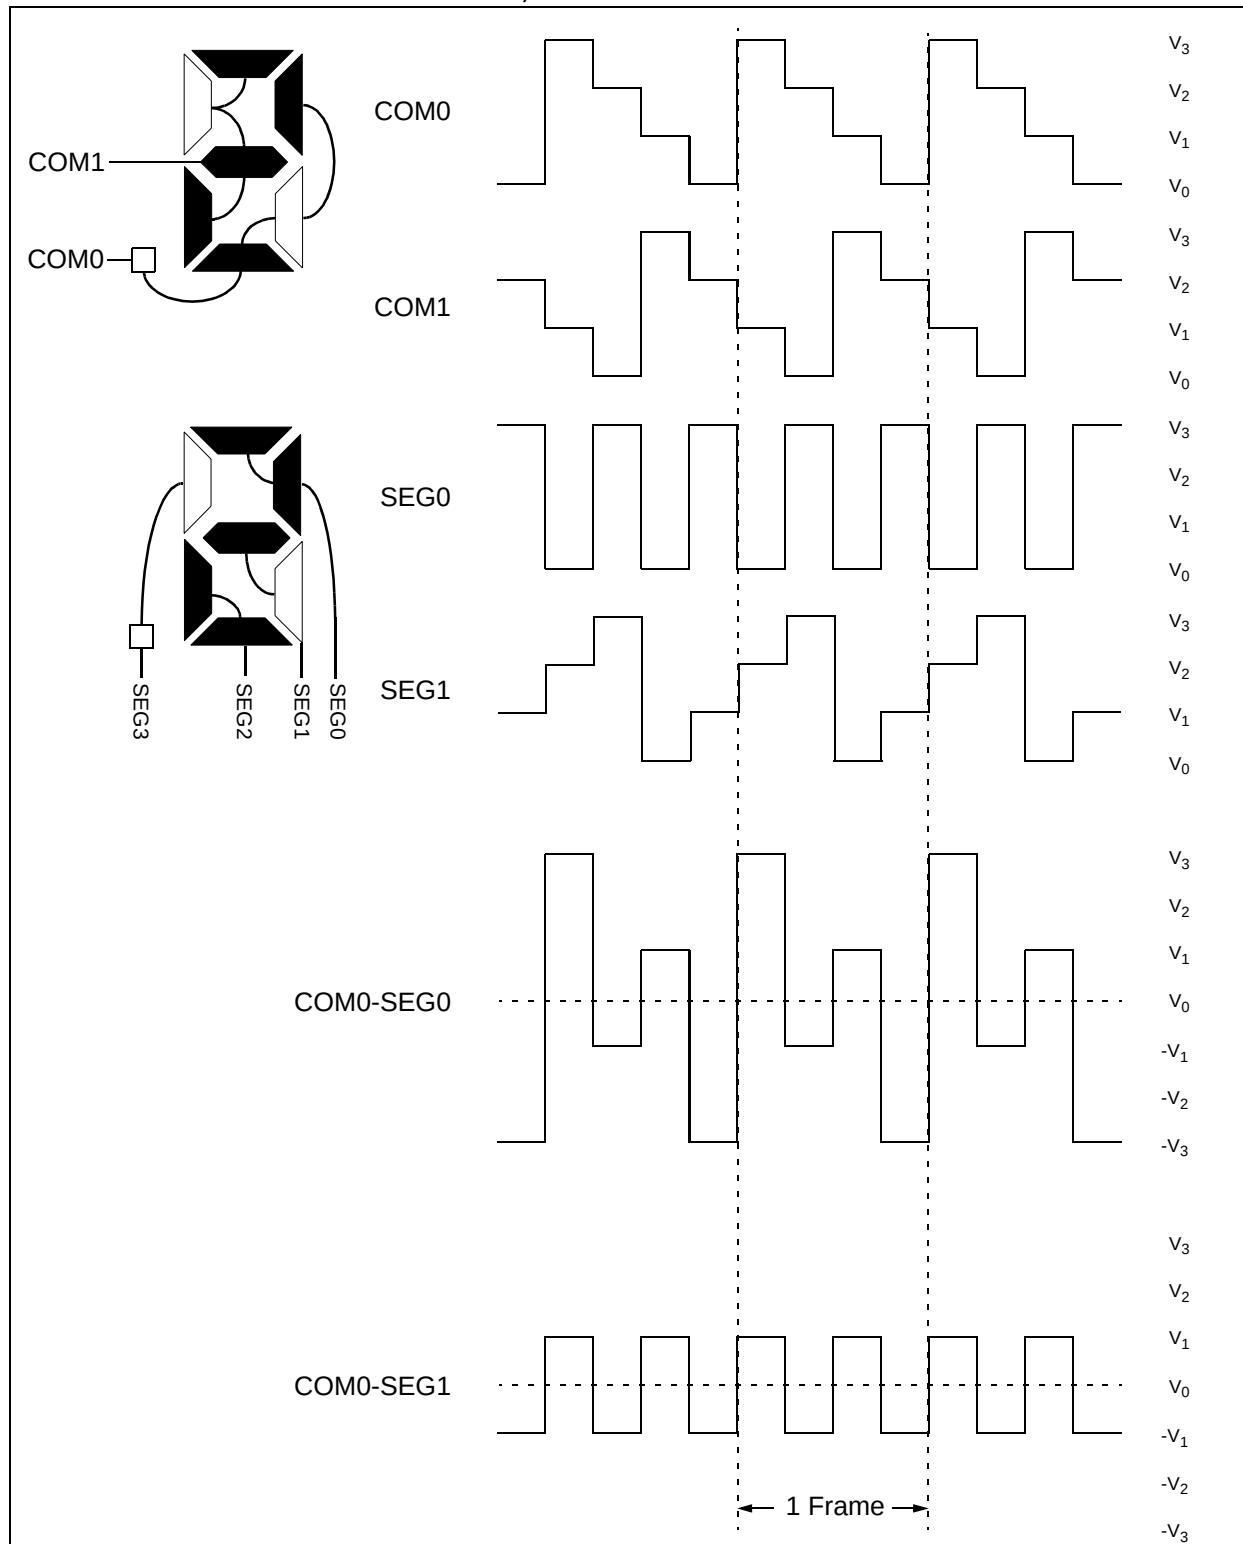
**FIGURE 3: WAVEFORMS IN 1/2 MUX, 1/3 BIAS DRIVE**

Figure 13-5 in the data sheet, depicting drive waveforms in 1/2 multiplex, 1/3 bias mode, is incorrect. Specifically, the connections for the

different LCD segments (SEG0 through SEG4) and the SEG1 drive waveform have been changed. The correct diagrams and waveforms are shown in Figure 3.
