## PIC16(L)F1826/1827 Family Silicon Errata and Data Sheet Clarification

The PIC16(L)F1826/1827 family devices that you have received conform functionally to the current Device Data Sheet (DS41391D), except for the anomalies described in this document.

**Note:** This document summarizes all silicon errata issues from all revisions of silicon, previous as well as current. Only the issues indicated in the last column of [Table 2](#) apply to the current silicon revision (**A7**).

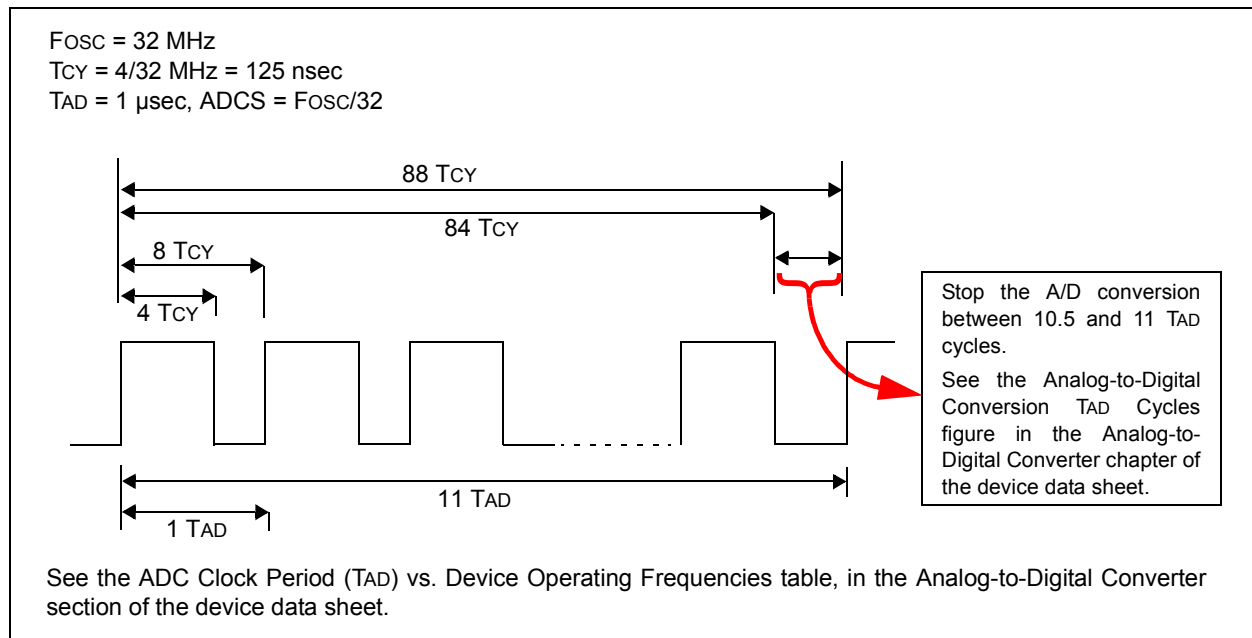
**FIGURE 1: INSTRUCTION CYCLE DELAY CALCULATION EXAMPLE**

An ADC conversion may not complete under these conditions:

1. When  $F_{OSC}$  is greater than 8 MHz and it is the clock source used for the ADC converter.
2. The ADC is operating from its dedicated internal FRC oscillator and the device is not in Sleep mode (any  $F_{OSC}$  frequency).

When this occurs, the ADC Interrupt Flag (ADIF) does not get set, the GO/DONE bit does not get cleared, and the conversion result does not get loaded into the ADRESH and ADRESL result registers.

In Figure 1, 88 instruction cycles (Tcy) will be required to complete the full conversion. Each TAD cycle consists of eight Tcy periods. A fixed delay is provided to stop the A/D conversion after 86 instruction cycles and terminate the conversion at the correct time as shown in the figure above.

Method 3: This method is provided if the application cannot use Sleep mode and requires continuous operation at frequencies above 8 MHz. This method requires early termination of an ADC conversion. Provide a fixed time delay in software to stop the A-to-D conversion manually, after all ten bits are converted, but before the conversion would complete automatically. The conversion is stopped by clearing the GO/DONE bit in software. The GO/DONE bit must be cleared during the last  $\frac{1}{2}$  TAD cycle, before the conversion would have completed automatically. Refer to Figure 1 for details.

**Note:** The exact delay time will depend on the TAD divisor (ADCS) selection. The Tcy counts shown in the timing diagram above apply to this example only. Refer to [Table 3](#) for the required delay counts for other configurations.
