## PIC16(L)F1933 Silicon Errata and Data Sheet Clarification

The PIC16(L)F1933 family devices that you have received conform functionally to the current Device Data Sheet (DS41575C), except for the anomalies described in this document.

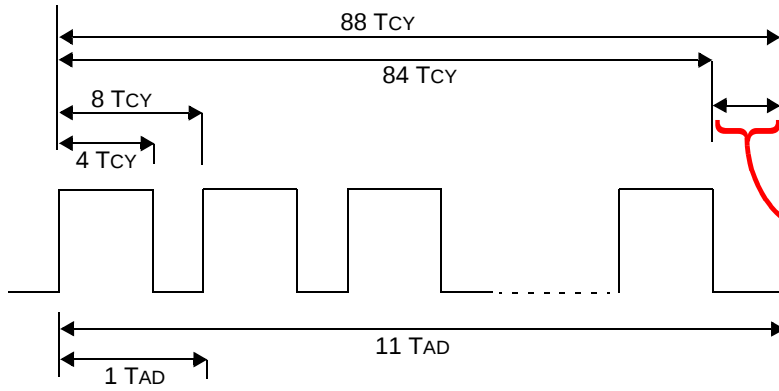
**FIGURE 1: INSTRUCTION CYCLE DELAY CALCULATION EXAMPLE**

An ADC conversion may not complete under these conditions:

1. When Fosc is greater than 8 MHz and it is the clock source used for the ADC converter.
2. The ADC is operating from its dedicated internal FRC oscillator and the device is not in Sleep mode (any Fosc frequency).

When this occurs, the ADC Interrupt Flag (ADIF) does not get set, the GO/DONE bit does not get cleared, and the conversion result does not get loaded into the ADRESH and ADRESL result registers.

In [Figure 1](#), 88 instruction cycles (TCY) will be required to complete the full conversion. Each TAD cycle consists of 8 TCY periods. A fixed delay is provided to stop the A/D conversion after 86 instruction cycles and terminate the conversion at the correct time as shown in the figure above.

Method 3: This method is provided if the application cannot use Sleep mode and requires continuous operation at frequencies above 8 MHz. This method requires early termination of an ADC conversion. Provide a fixed time delay in software to stop the A-to-D conversion manually, after all 10 bits are converted, but before the conversion would complete automatically. The conversion is stopped by clearing the GO/DONE bit in software. The GO/DONE bit must be cleared during the last ½ TAD cycle, before the conversion would have completed automatically. Refer to [Figure 1](#) for details.

Stop the A/D conversion between 10.5 and 11 TAD cycles.  
 See the Analog-to-Digital Conversion Timing diagram in the Analog-to-Digital Converter chapter of the device data sheet.

**Note:** The exact delay time will depend on the TAD divisor (ADCS) selection. The TCY counts shown in the timing diagram above apply to this example only. Refer to [Table 4](#) for the required delay counts for other configurations.

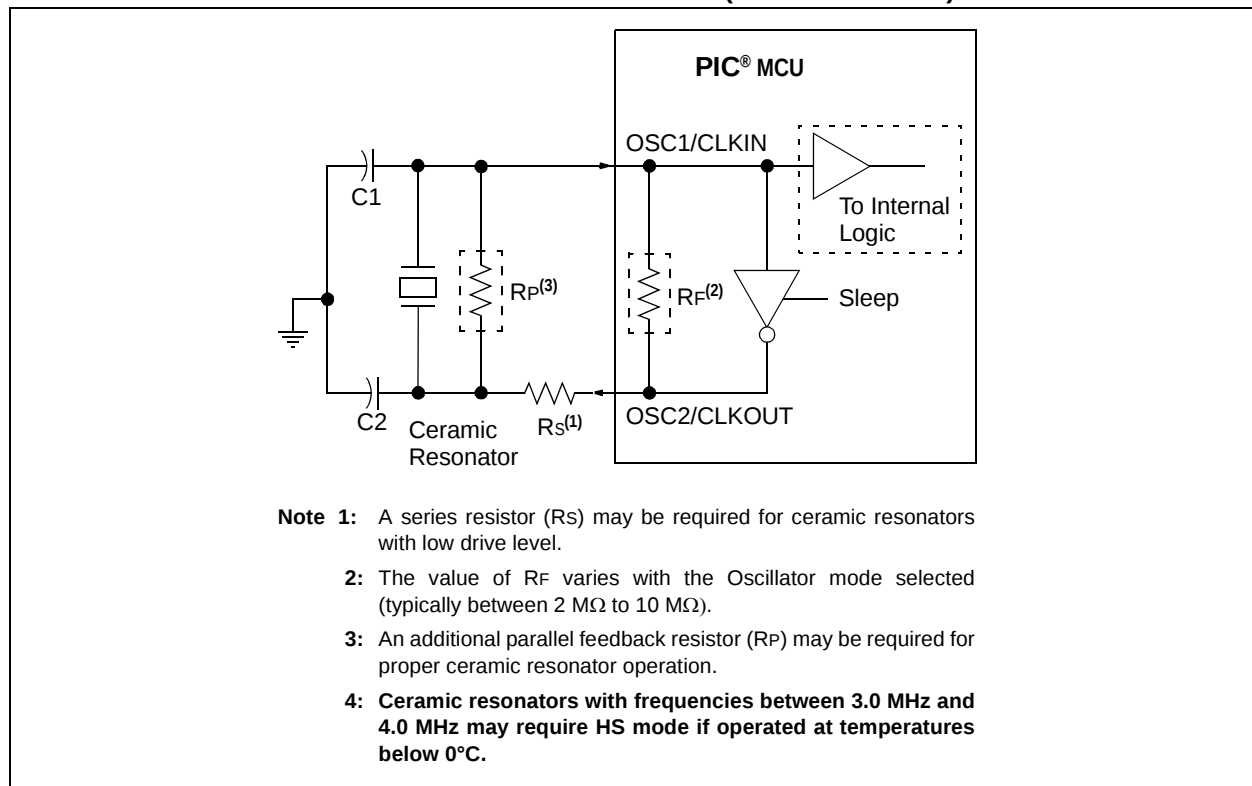
**FIGURE 5-4: CERAMIC RESONATOR OPERATION (XT OR HS MODE)**

In [Figure 5-4](#), note 4 is added as following:
