## PIC16F627A/628A/648A Rev. A Silicon/Data Sheet Errata

The PIC16F627A/628A/648A parts you have received conform functionally to the Device Data Sheet (DS40044F), except for the anomalies described below.

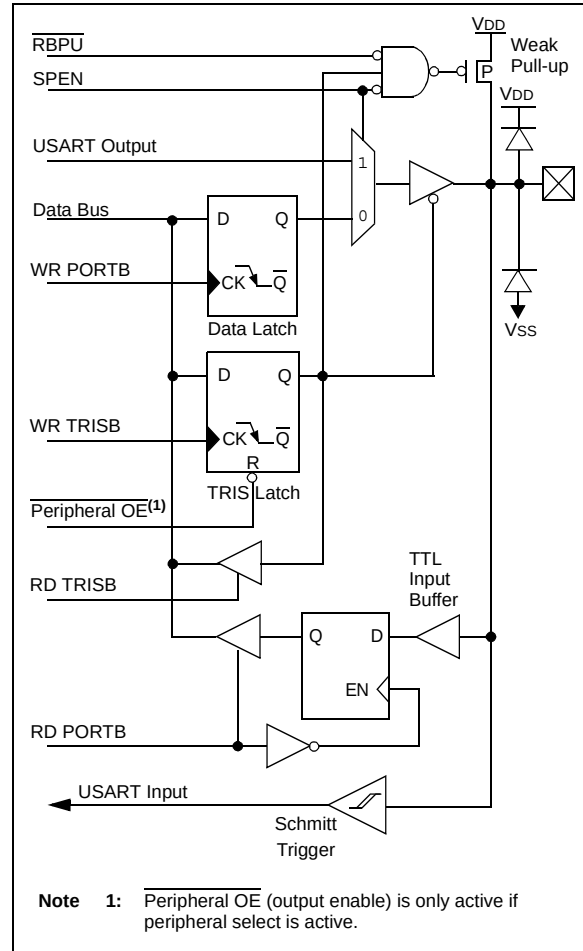
FIGURE 1: BLOCK DIAGRAM OF RB1, RB2

1. USART control of the RB1/RX/DT and RB2/TX/CK differs from the data sheet. Figure 5-9 and Figure 5-10 indicate that the USART circuit overrides the output drivers via the Peripheral OE signal. In fact, the Peripheral OE signal forces the TRISB<2:1> to an output (Reset) state (see Figure 1). Subsequently, the TRISB<2:1> must be set or configured to receive data.

In Asynchronous mode, when transmit is enabled (TXEN = 1 and SPEN = 1), the TRISB<2> latch is cleared to '0' by the USART peripheral circuitry. When disabling transmit (TXEN = 0), the TRISB<2> bit should be set to '1' to configure the RB2/TX/CK pin as an input.

In Synchronous mode, when changing from transmit to receive, clear the TXEN bit first, then set TRISB<1> to '1' to configure the RB1/RX/DT pin as an input before setting SREN or CREN to receive.

When disabling the USART (SPEN = 0), TRIS<2:1> should be reconfigured for input or output as required by the application.

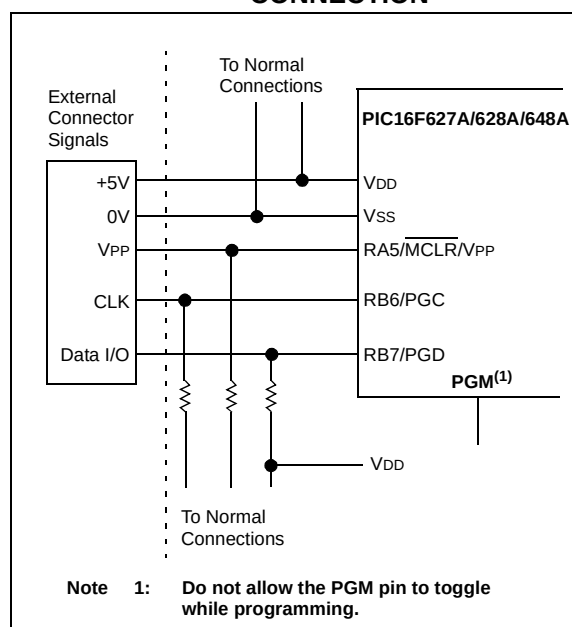
**FIGURE 14-18: TYPICAL IN-CIRCUIT SERIAL PROGRAMMING™ CONNECTION**

Section 14.11: In-Circuit Serial Programming and Figure 14-18: Typical In-Circuit Serial Programming Connection. The following paragraph and Note box are being added to the end of Section 14.11 and Figure 14-18 is updated to include PGM, noted in bold.

If LVP is not being used for programming, but the LVP Configuration bit is set (or LVP feature is enabled), the PGM pin must not be allowed to toggle while programming. The PGM pin is edge sensitive and if an edge is detected during programming, it may cause the PC to reset. If the LVP feature is disabled, the PGM pin will have no effect on programming.
