## PIC16F684 Rev. A Silicon/Data Sheet Errata

The PIC16F684 parts you have received conform functionally to the Device Data Sheet (DS41202D), except for the anomalies described below.

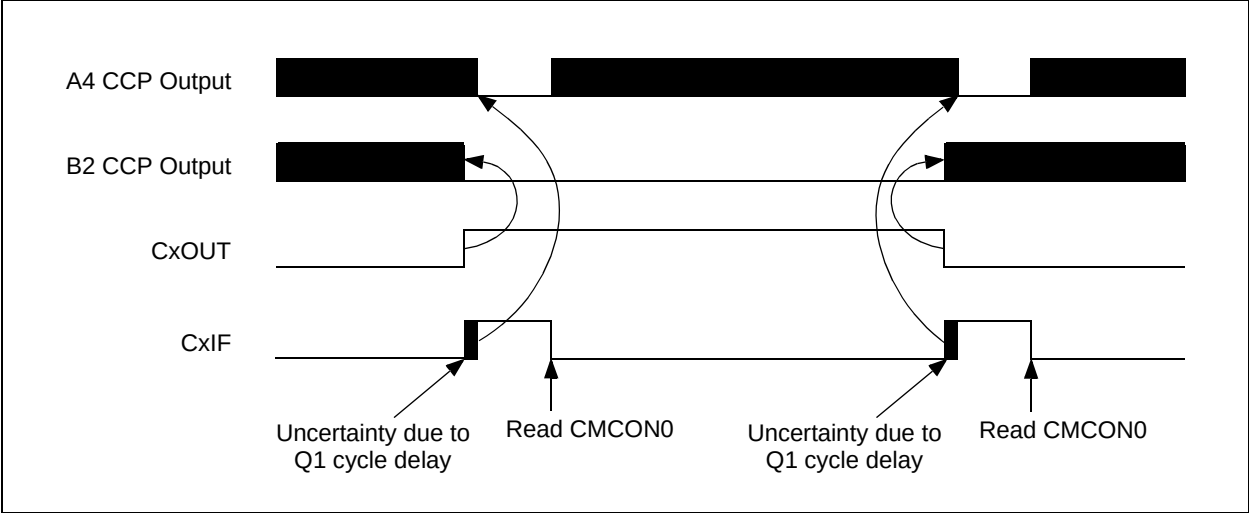
FIGURE 1: SILICON REVISION A4 VS. REVISION B2

The PIC16F684 Rev. A4 silicon for the ECCP Auto-Shutdown is connected to the C1IF and C2IF flags. See Figures 8-2 and 8-3 on the following page.

Rev. A4's auto-shutdown connection to C1IF and C2IF causes the auto-shutdown to incorrectly operate synchronously. Additionally, reads of CMCON0 will incorrectly clear an auto-shutdown event.

The Silicon Rev. B2 device (now shipping) has moved the auto-shutdown connection from CxIF to CxOUT. This will eliminate the synchronous shutdown and simplify the use of the comparator for a shutdown event. Figure 1 shows the function of auto-shutdown before and after the device revision.

- 1) Poll the CxOUT bit until it is low.
- 2) Read CMCON1 to precondition CxIF.
- 3) If CMCON0 is read while CxOUT is changing, repeat steps 1 and 2.
