## PIC16F631/677/685/687/689/690 Family Silicon Errata and Data Sheet Clarification

The PIC16F631/677/685/687/689/690 family devices that you have received conform functionally to the current Device Data Sheet (DS41262E), except for the anomalies described in this document.

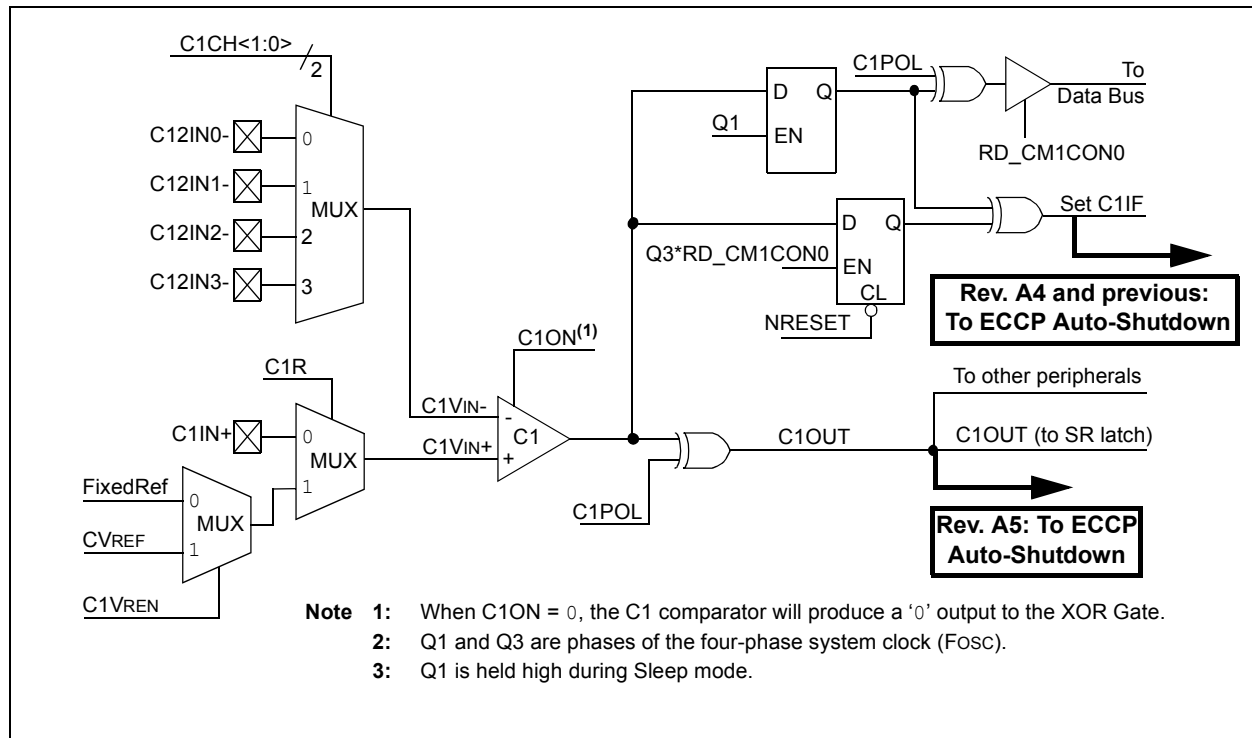
FIGURE 8-2: COMPARATOR C1 SIMPLIFIED BLOCK DIAGRAM

The PIC16F631/677/685/687/689/690 Rev. A4 silicon for the ECCP auto-shutdown is connected to the C1IF and C2IF flags. See Figures 8-2 and 8-3 on the following page.

The auto-shutdown connection (Rev. A4 and previous) to C1IF and C2IF causes the auto-shutdown to incorrectly operate synchronously. Additionally, reads of CMxCON0 will incorrectly clear an auto-shutdown event.

- 1) Poll the CxOUT bit until it is low.
- 2) Read CMxCON0 to precondition CxIF.
- 3) If CMxCON0 is read while CxOUT is changing, repeat steps 1 and 2.

The Silicon Rev. A5 (now shipping) and later revision devices have moved the auto-shutdown connection from CxIF to CxOUT. This will eliminate the synchronous shutdown and simplify the use of the comparator for a shutdown event. Figure 1 shows the function of auto-shutdown before and after the device revision.
