## PIC16F818/819 Rev. A4 Silicon Errata Sheet

The PIC16F818/819 Rev. A4 parts you have received conform functionally to the Device Data Sheet (DS39598E), except for the anomalies described below.

**The following silicon errata apply only to PIC16F818/819 devices with these Device/Revision IDs:**

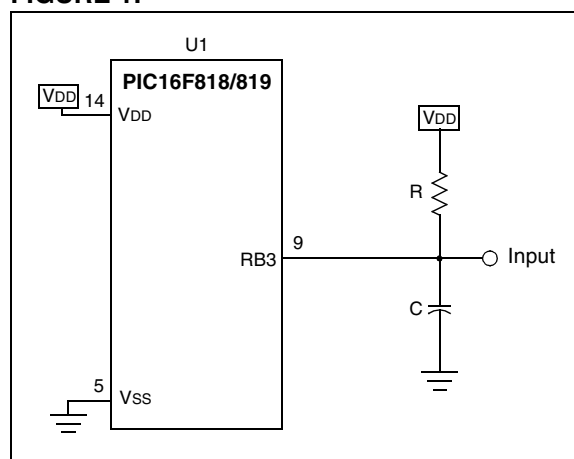
**FIGURE 1:**

If the following conditions are present on RB3, a device Reset may occur.

1. RC combination on RB3 (see Figure 1).
2. RB3 configured as an input via TRISB.
3. RB3 is driven low.

1. A Reset condition may not occur if a specific resistor/capacitor combination is used. It has been observed that a 10 kΩ resistor and a capacitor value of 4.7 nF or less does not cause a device Reset. If the user must have a RC configuration using RB3, then experimenting with different RC values is recommended.
2. Do not configure RB3 with the above conditions shown in Figure 1. Instead, use another I/O pin for the RC configuration.
