## PIC16F88X Family Silicon Errata and Data Sheet Clarification

The PIC16F88X family devices that you have received conform functionally to the current Device Data Sheet (DS41291G), except for the anomalies described in this document.

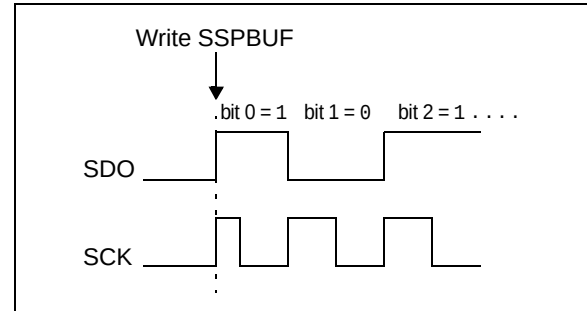
**FIGURE 1: SCK PULSE VARIATION USING TIMER2/2**

When the SPI is using Timer2/2 as the clock source, a shorter than expected SCK pulse may occur on the first bit of the transmitted/received data (Figure 1).

To avoid producing the short pulse, turn off Timer2 and clear the TMR2 register, load SSPBUF with the data to transmit and then turn Timer2 back on. Refer to Example 1 for sample code.

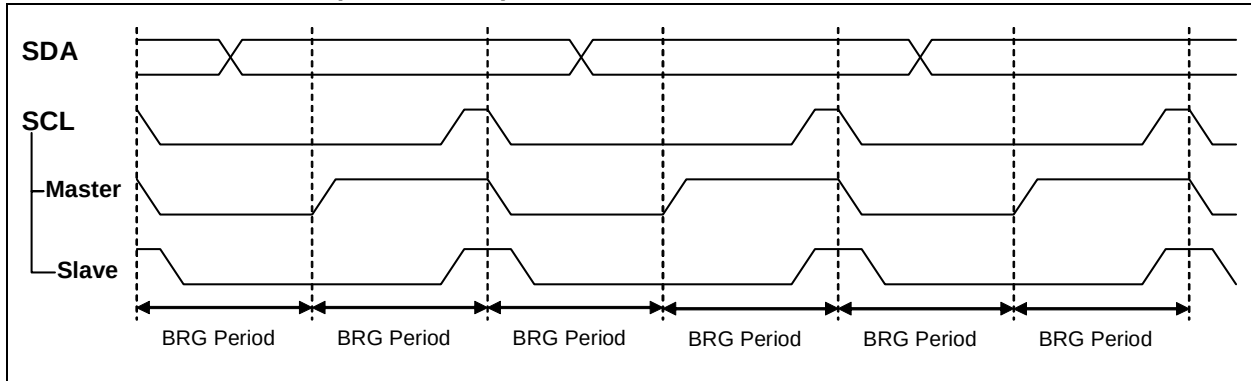
**FIGURE 3: ACTUAL (INCORRECT) OPERATION WITH CLOCK STRETCHING – EXAMPLE 1**

The current implementation does not ensure accurate SCL high time. During clock stretch, the MSSP device will erroneously continue running the BRG counter. At the end of the clock stretch, the BRG counter continues to count down for the

remainder of the BRG period, and then the MSSP device will immediately resume transmitting the data.

Figure 3 and Figure 4 illustrate an actual I<sup>2</sup>C transmission in which the slave has stretched the clock period by holding the SCL line low. Note that the high time of the SCL signal has shortened from the expected time.

Set the communication speed to match the slowest device on the bus. This ensures that no slave device will perform clock stretching.

It is possible to dynamically adjust the communication speed to match the device being addressed by modifying the BRG register. However, the behavior of slower slave devices must be understood and speed adjustments made such that no slave performs clock stretching.
