## PIC18CXX2 Rev. B Silicon/Data Sheet Errata

The PIC18CXX2 (Rev. B) parts you have received conform functionally to the Device Data Sheet (DS39026C), except for the anomalies described below.

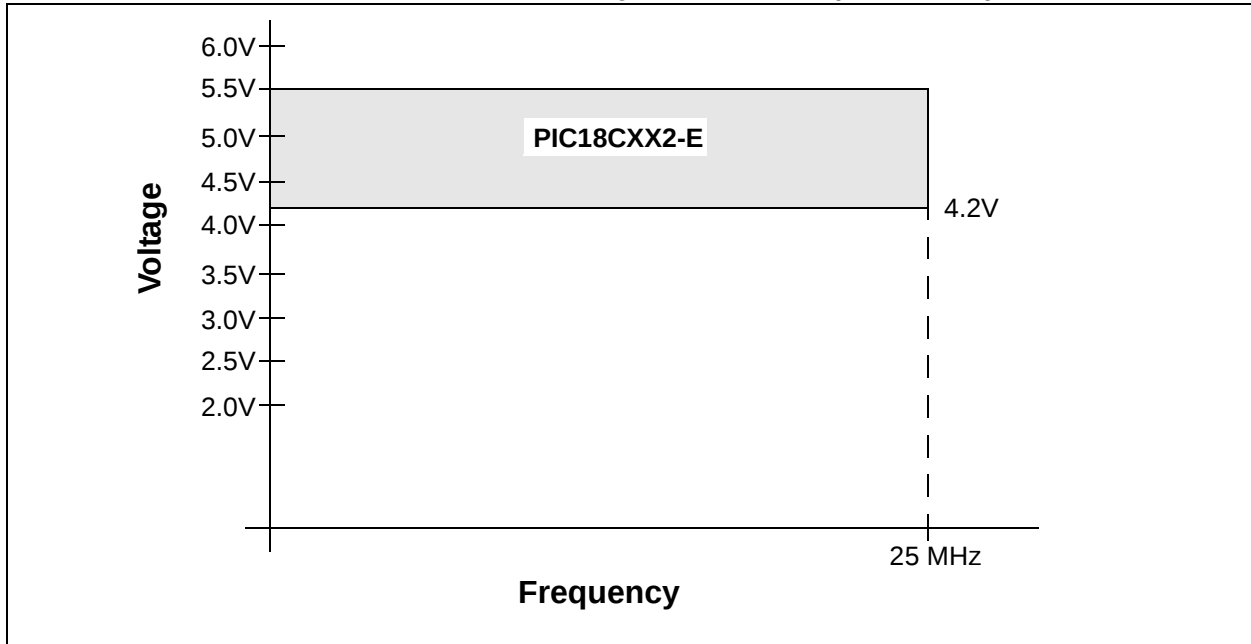
**FIGURE 21-3: PIC18CXX2 VOLTAGE-FREQUENCY GRAPH (EXTENDED)**

The operating frequency range for extended temperature devices has been changed.

The maximum external clock frequency (EC and ECIO modes) and oscillator frequency (HS mode) for extended temperature devices has been changed to 25 MHz. When the PLL is used

(HS+PLL mode), the maximum clock and oscillator frequency has been changed to 6.25 MHz. Other values of related parameters have changed accordingly.

Figure 21-3 (below), reflecting the voltage-frequency performance of extended temperature devices, is added to the Device Data Sheet:

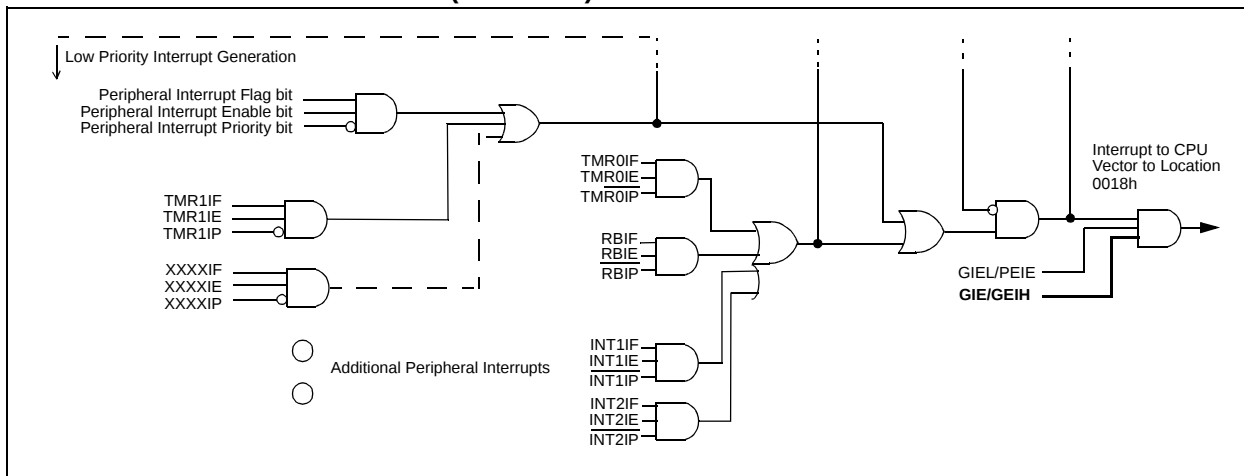
FIGURE 1: INTERRUPT LOGIC (EXCERPT)

The operation of the GIE/GIEH bit (INTCON<7>) is clarified as follows: when the bit is cleared, all interrupts are disabled. This is regardless of the state of the IPEN bit (RCON<7>), the priority of the interrupt, or whether or not the interrupt is unmasked. This varies from the original description, in which clearing the bit when IPEN = '1' would only disable high priority interrupts.

Also, the interrupt logic funnel shown in Figure 7-1 of the Device Data Sheet is amended with the addition of a GIE/GIEH control line, as shown in Figure 1 (new material in **bold line**).
