## PIC18F85J90 Family Silicon Errata and Data Sheet Clarification

The PIC18F85J90 family devices that you have received conform functionally to the current Device Data Sheet (DS39770C), except for the anomalies described in this document.

**Note:** This document summarizes all silicon errata issues from all revisions of silicon, previous as well as current. Only the issues indicated in the last column of [Table 2](#) apply to the current silicon revision (**A6**).

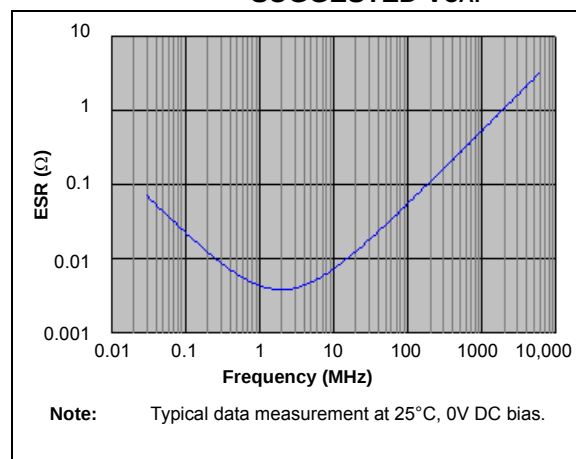
**FIGURE 2-3 FREQUENCY vs. ESR PERFORMANCE FOR SUGGESTED VCAP**

When the regulator is enabled, a low-ESR ( $< 5\Omega$ ) capacitor is required on the VCAP/VDDCORE pin to stabilize the voltage regulator output voltage. The VCAP/VDDCORE pin must not be connected to VDD and must use a capacitor of 10  $\mu\text{F}$  connected to ground. The type can be ceramic or tantalum. Suitable examples of capacitors are shown in [Table 2-1](#). Capacitors with equivalent specification can be used.

Designers may use [Figure 2-3](#) to evaluate ESR equivalence of candidate devices.

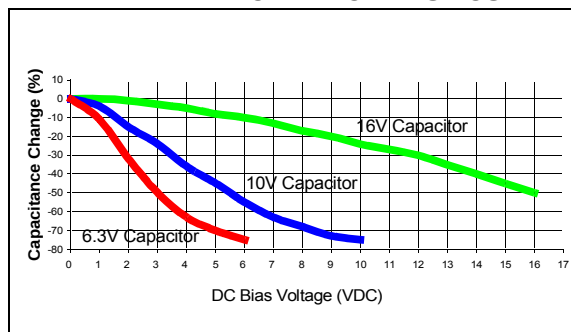
**FIGURE 2-4 DC BIAS VOLTAGE vs. CAPACITANCE CHARACTERISTICS**

In addition to temperature tolerance, the effective capacitance of large value ceramic capacitors can vary substantially, based on the amount of DC voltage applied to the capacitor. This effect can be very significant, but is often overlooked or is not always documented.

A typical DC bias voltage vs. capacitance graph for X7R type and Y5V type capacitors is shown in Figure 2-4.

When selecting a ceramic capacitor to be used with the VDDCORE voltage regulator, it is suggested to select a high-voltage rating, so that the operating voltage is a small percentage of the maximum rated capacitor voltage. For example, choose a ceramic capacitor rated at 16V for the 2.5V VDDCORE voltage. Suggested capacitors are shown in Table 2-1.
