## PIC18(L)F1XK22 Family Silicon Errata and Data Sheet Clarification

The PIC18(L)F1XK22 family devices that you have received conform functionally to the current Device Data Sheet (DS40001365F), except for the anomalies described in this document.

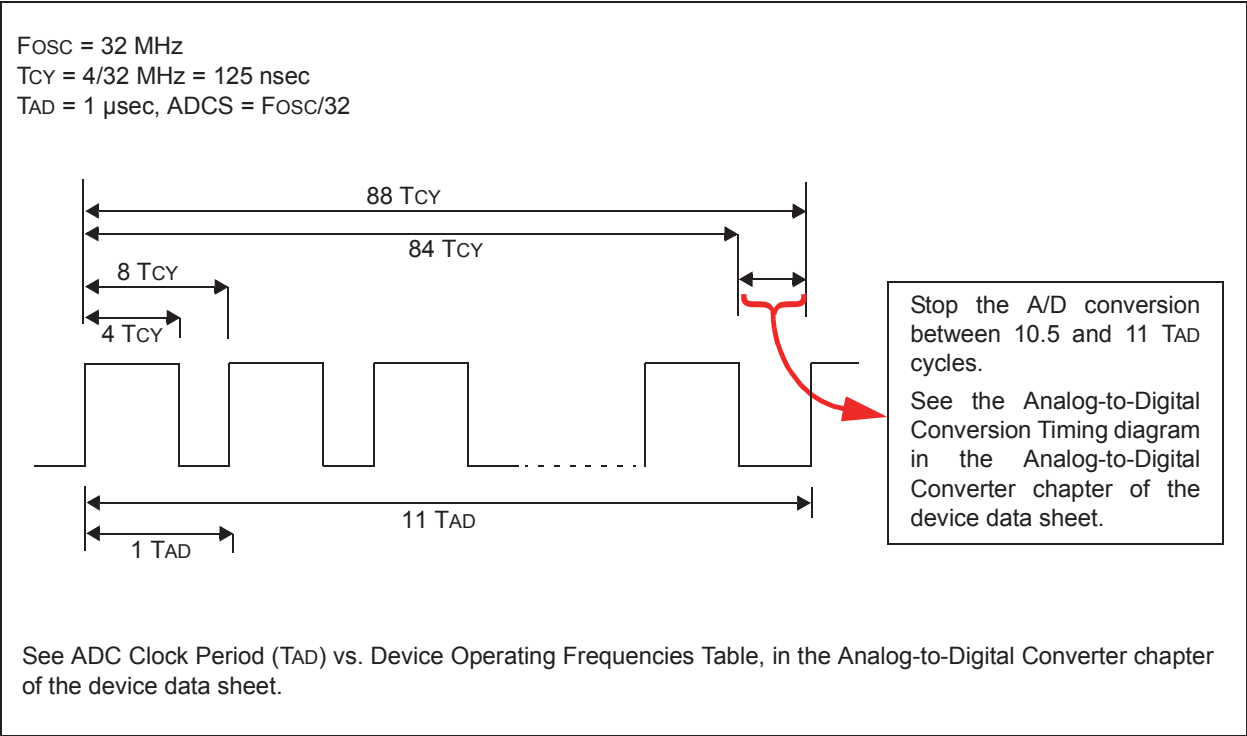
FIGURE 1: INSTRUCTION CYCLE DELAY CALCULATION EXAMPLE

An ADC conversion may not complete under these conditions:

1. When Fosc is greater than 8 MHz and is the clock source used for the ADC converter.
2. The ADC is operating from its dedicated internal FRC oscillator and the device is not in Sleep mode (an Fosc frequency).

When this occurs, the ADC Interrupt Flag (ADIF) does not get set, the GO/DONE bit does not get cleared, and the conversion result does not get loaded into the ADRESH and ADRESL result registers.

In Figure 1, 88 instruction cycles (TCY) will be required to complete the full conversion. Each TAD cycle consists of eight TCY periods. A fixed delay is provided to stop the A/D conversion after 86 instruction cycles and terminate the conversion at the correct time as shown in the figure above.

Method 3: Method 3 is provided if the application cannot use Sleep mode and requires continuous operation at frequencies above 8 MHz. This method requires early termination of an ADC conversion. Provide a fixed time delay in software to stop the Analog-to-Digital conversion manually, after all ten bits are converted, but before the conversion would complete automatically. The conversion is stopped by clearing the GO/DONE bit in software. The GO/DONE bit must be cleared during the last ½ TAD cycle, before the conversion would have completed automatically. Refer to [Figure 1](#) for details.

**Note:** The exact delay time will depend on the TAD divisor (ADCS) selection. The TCY counts shown in the timing diagram above apply to this example only. Refer to Table 3 for the required delay counts for other configurations.
