## PIC18F2410/2510/4410/4510 Rev. B4 Silicon Errata

The PIC18F2410/2510/4410/4510 Rev. B4 parts you have received conform functionally to the Device Data Sheet (DS39636D), except for the anomalies described below. Any Data Sheet Clarification issues related to the PIC18F2410/2510/4410/4510 will be reported in a separate Data Sheet errata. Please check the Microchip web site for any existing issues.

The following silicon errata apply only to PIC18F2410/2510/4410/4510 devices with these Device/Revision IDs:

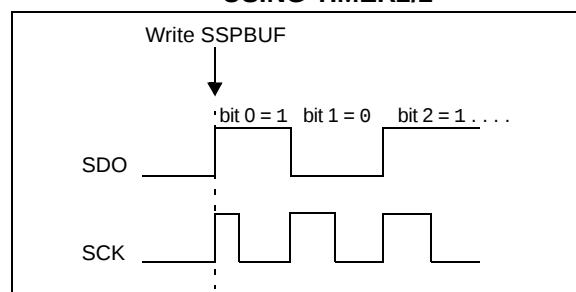
**FIGURE 1: SCK PULSE VARIATION USING TIMER2/2**

### 2. Module: MSSP (SPI Mode)

When the SPI is using Timer2/2 as the clock source, a shorter than expected SCK pulse may occur on the first bit of the transmitted/received data (Figure 1).

#### Work around

To avoid producing the short pulse, turn off Timer2 and clear the TMR2 register, load the SSPBUF with the data to transmit and then turn Timer2 back on. Refer to Example 1 for sample code.
