## PIC18F2410/2510/4410/4510 Rev. A1 Silicon Errata

The PIC18F2410/2510/4410/4510 Rev. A1 parts you have received conform functionally to the Device Data Sheet (DS39636D), except for the anomalies described below. Any Data Sheet Clarification issues related to the PIC18F2410/2510/4410/4510 will be reported in a separate Data Sheet errata. Please check the Microchip web site for any existing issues.

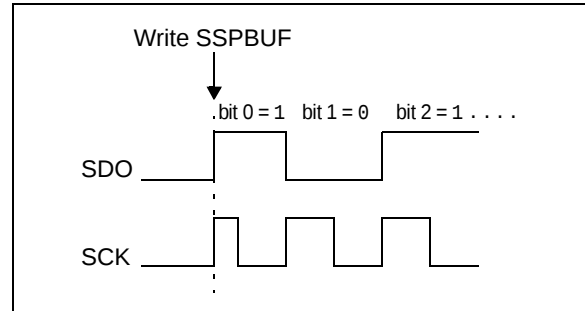
**FIGURE 1: SCK PULSE VARIATION USING TIMER2/2**

When the SPI is using Timer2/2 as the clock source, a shorter than expected SCK pulse may occur on the first bit of the transmitted/received data (Figure 1).

### Work around

To avoid producing the short pulse, turn off Timer2 and clear the TMR2 register, load the SSPBUF with the data to transmit and then turn Timer2 back on. Refer to Example 6 for sample code.
