## PIC18F2410/2510/4410/4510 Rev. B3 Silicon Errata

# PIC18F2410/2510/4410/4510

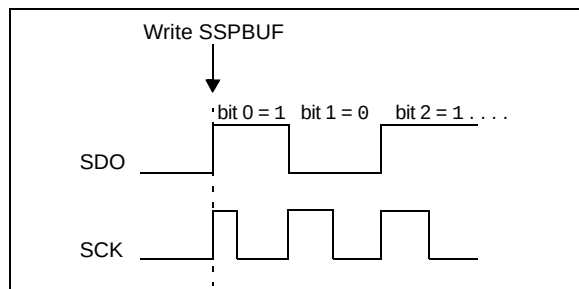
**FIGURE 1: SCK PULSE VARIATION USING TIMER2/2**

When the SPI is using Timer2/2 as the clock source, a shorter than expected SCK pulse may occur on the first bit of the transmitted/received data ([Figure 1](#)).

To avoid producing the short pulse, turn off Timer2 and clear the TMR2 register, load the SSPBUF with the data to transmit and then turn Timer2 back on. Refer to [Example 1](#) for sample code.
