**MICROCHIP****PIC18F2420/2520/4420/4520****PIC18F2420/2520/4420/4520 Rev. A1 Silicon Errata Sheet**

**The following silicon errata apply only to PIC18F2420/2520/4420/4520 devices with these Device/Revision IDs:**

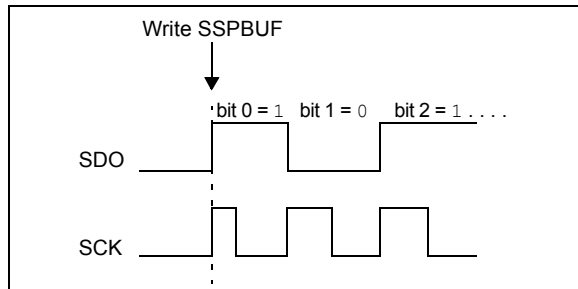
**FIGURE 1: SCK PULSE VARIATION USING TIMER2/2**

When the SPI is using Timer2/2 as the clock source, a shorter than expected SCK pulse may occur on the first bit of the transmitted/received data (Figure 1).

To avoid producing the short pulse, turn off Timer2 and clear the TMR2 register, load the SSPBUF with the data to transmit and then turn Timer2 back on. Refer to Example 4 for sample code.
