**MICROCHIP****PIC18F2420/2520/4420/4520****PIC18F2420/2520/4420/4520 Rev. B2 Silicon Errata**

The PIC18F2420/2520/4420/4520 Rev. B2 parts you have received conform functionally to the Device Data Sheet (DS39631C), except for the anomalies described below. Any Data Sheet Clarification issues related to the PIC18F2420/2520/4420/4520 will be reported in a separate Data Sheet errata. Please check the Microchip web site for any existing issues.

The following silicon errata apply only to PIC18F2420/2520/4420/4520 devices with these Device/Revision IDs:

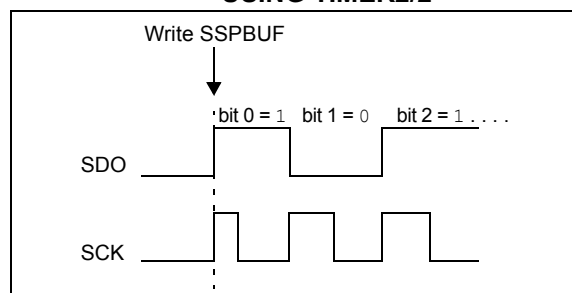
**FIGURE 1: SCK PULSE VARIATION USING TIMER2/2**

When the SPI is using Timer2/2 as the clock source, a shorter than expected SCK pulse may occur on the first bit of the transmitted/received data (Figure 1).

To avoid producing the short pulse, turn off Timer2 and clear the TMR2 register, load the SSPBUF with the data to transmit and then turn Timer2 back on. Refer to Example 2 for sample code.
