**MICROCHIP****PIC18F2420/2520/4420/4520****PIC18F2420/2520/4420/4520 Rev. B4 Silicon Errata**

The PIC18F2420/2520/4420/4520 Rev. B4 parts you have received conform functionally to the Device Data Sheet (DS39631E), except for the anomalies described below. Any Data Sheet Clarification issues related to the PIC18F2420/2520/4420/4520 will be reported in a separate Data Sheet errata. Please check the Microchip web site for any existing issues.

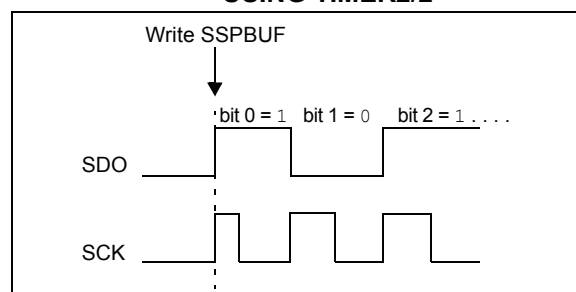
**FIGURE 1: SCK PULSE VARIATION USING TIMER2/2**

When the SPI is using Timer2/2 as the clock source, a shorter than expected SCK pulse may occur on the first bit of the transmitted/received data (Figure 1).

To avoid producing the short pulse, turn off Timer2 and clear the TMR2 register, load the SSPBUF with the data to transmit and then turn Timer2 back on. Refer to Example 1 for sample code.
