## PIC18F2480/2580/4480/4580 Silicon Errata and Data Sheet Clarification

The PIC18F2480/2580/4480/4580 family devices that you have received conform functionally to the current Device Data Sheet (DS39637D), except for the anomalies described in this document.

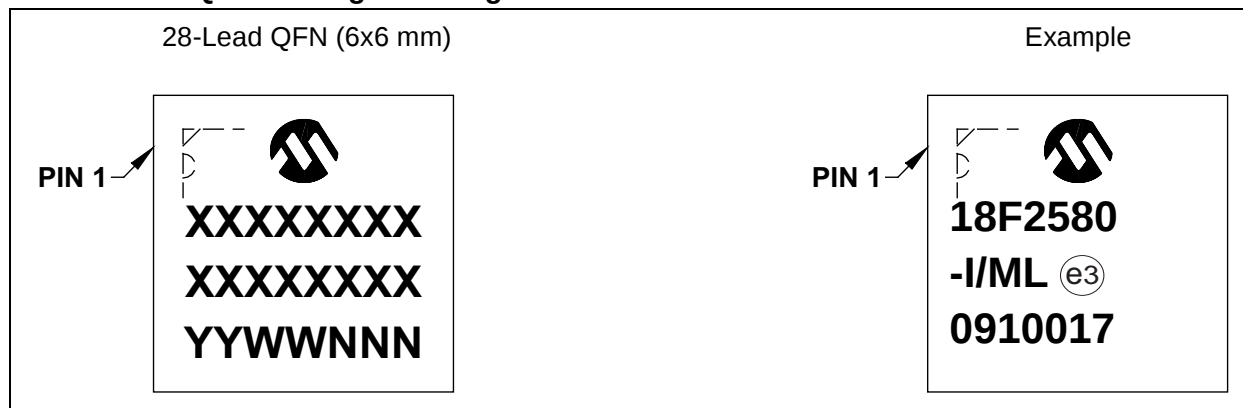
#### 29.1 28-Lead QFN Package Marking Information

The “Pin 1” dot on the 28-Lead QFN package, in the Package Marking Information section, is incorrectly placed. The correct placement is indicated in [Section 29.1 “28-Lead QFN Package Marking Information”](#) below:
