## PIC18F45J10 Family Silicon Errata and Data Sheet Clarification

The PIC18F45J10 family devices that you have received conform functionally to the current Device Data Sheet (DS39682E), except for the anomalies described in this document.

The silicon issues discussed in the following pages are for silicon revisions with the Device and Revision IDs listed in [Table 1](#). The silicon issues are summarized in [Table 2](#).

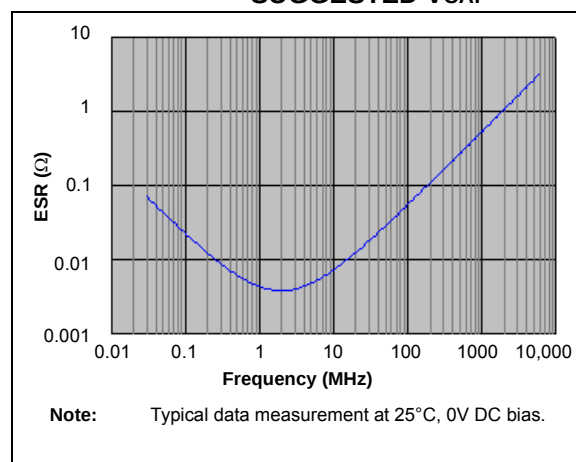
**FIGURE 2-3** FREQUENCY vs. ESR PERFORMANCE FOR SUGGESTED VCAP

When the regulator is enabled (F devices), a low-ESR ( $< 5\Omega$ ) capacitor is required on the VCAP/VDDCORE pin to stabilize the voltage regulator output voltage. The VCAP/VDDCORE pin must not be connected to VDD and must use a capacitor of 10  $\mu\text{F}$  connected to ground. The type can be ceramic or tantalum. Suitable examples of capacitors are shown in [Table 2-1](#). Capacitors with equivalent specifications can be used.

Designers may use [Figure 2-3](#) to evaluate ESR equivalence of candidate devices.

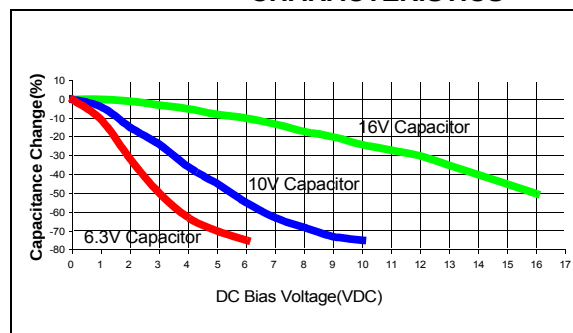
**FIGURE 2-4 DC BIAS VOLTAGE vs. CAPACITANCE CHARACTERISTICS**

In addition to temperature tolerance, the effective capacitance of large value ceramic capacitors can vary substantially, based on the amount of DC voltage applied to the capacitor. This effect can be very significant, but is often overlooked or is not always documented.

A typical DC bias voltage vs. capacitance graph for 16V, 10V and 6.3V rated capacitors is shown in Figure 2-4.

When selecting a ceramic capacitor to be used with the internal voltage regulator, it is suggested to select a high-voltage rating, so that the operating voltage is a small percentage of the maximum rated capacitor voltage. For example, choose a ceramic capacitor rated at 16V for the 2.5V core voltage. Suggested capacitors are shown in Table 2-1.
